Appendix One - Photographs

Property One: before and after photos

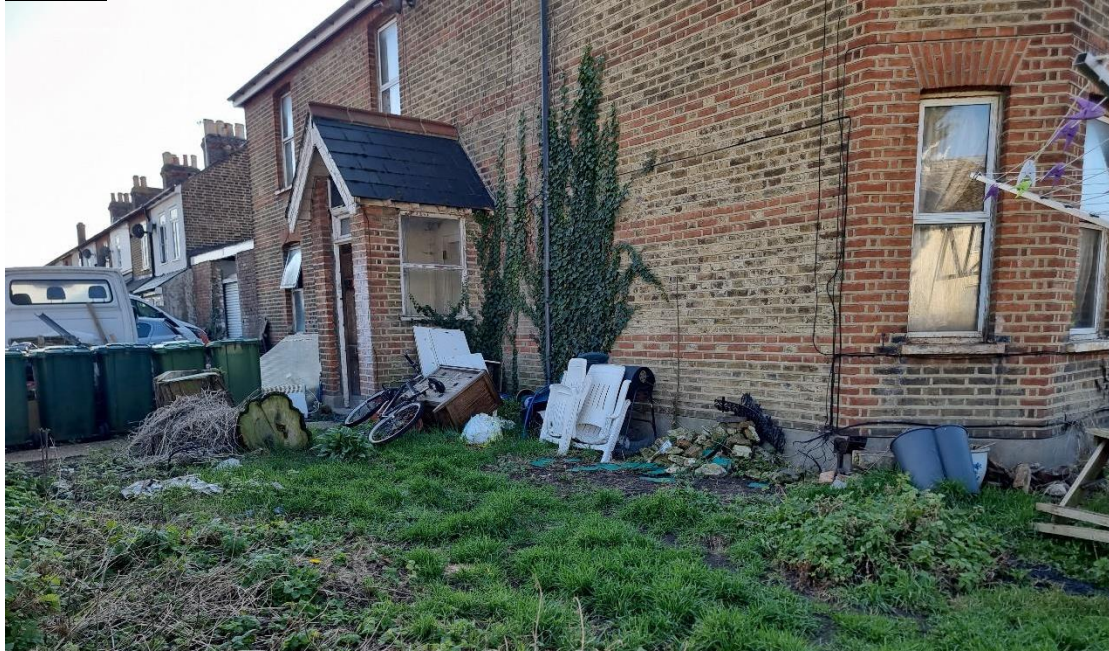
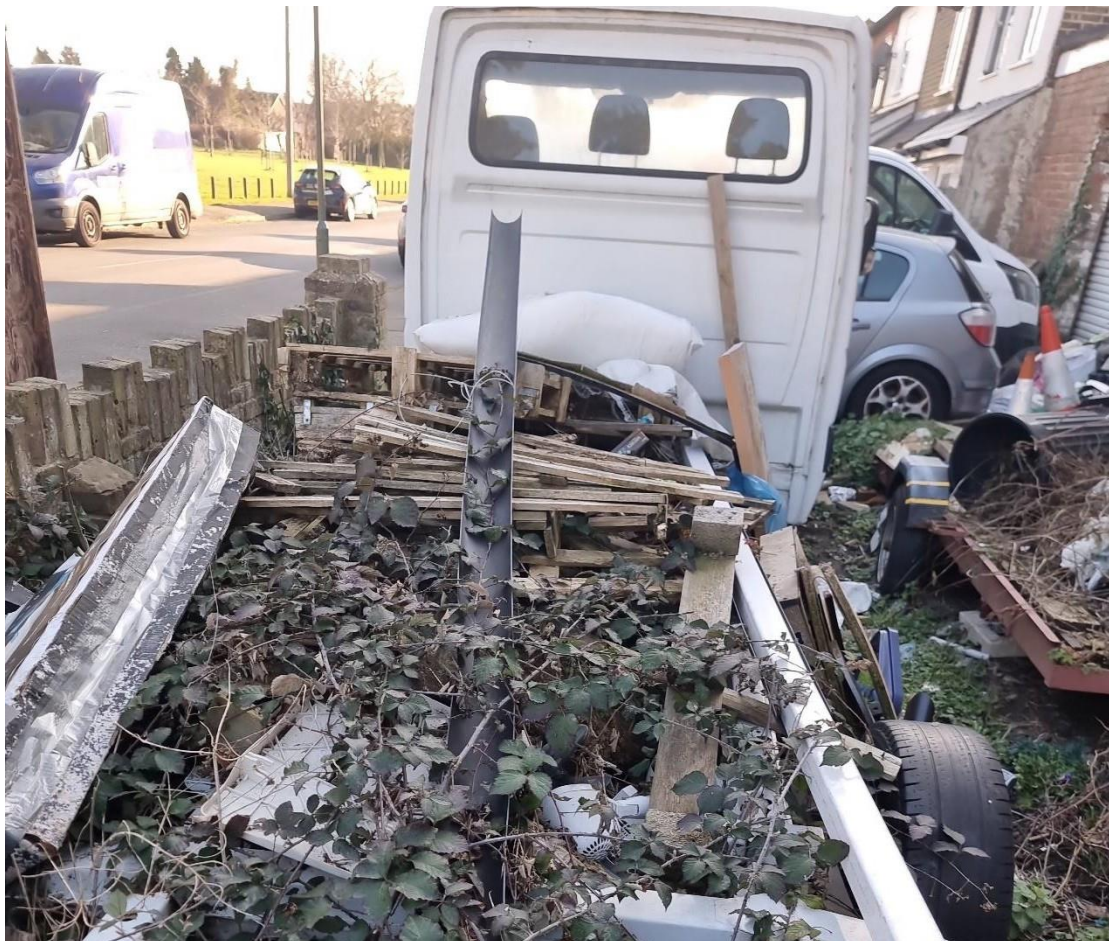
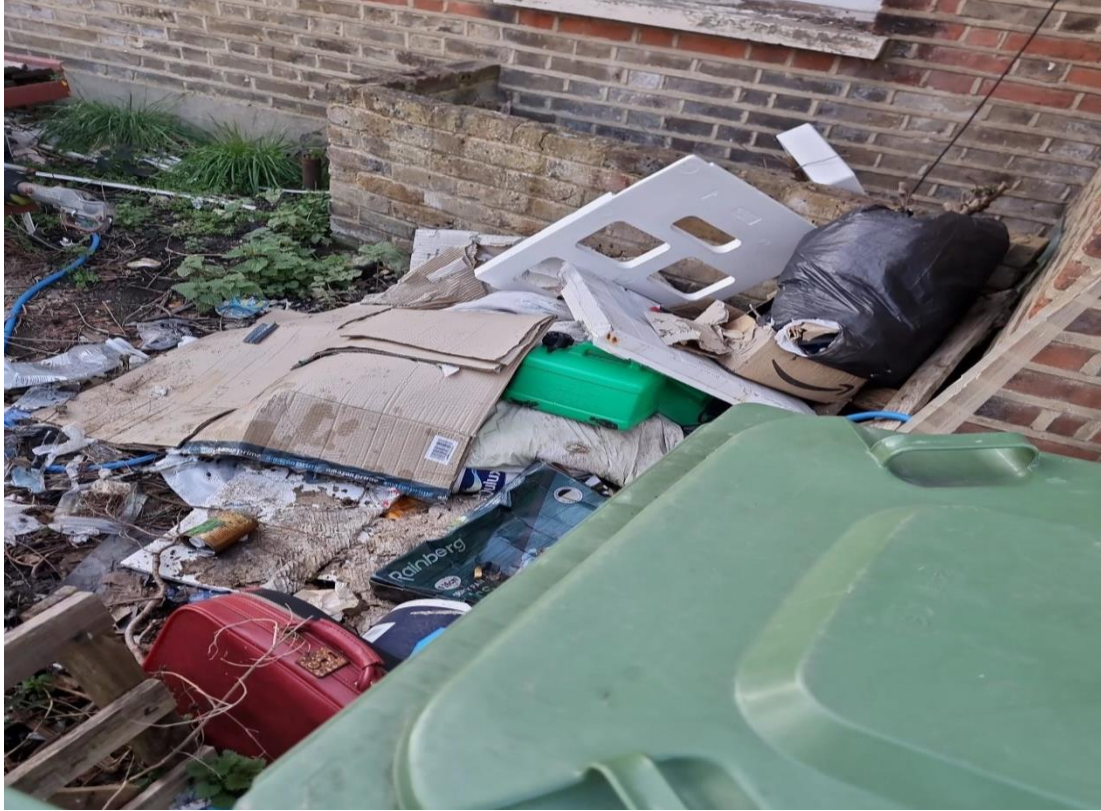
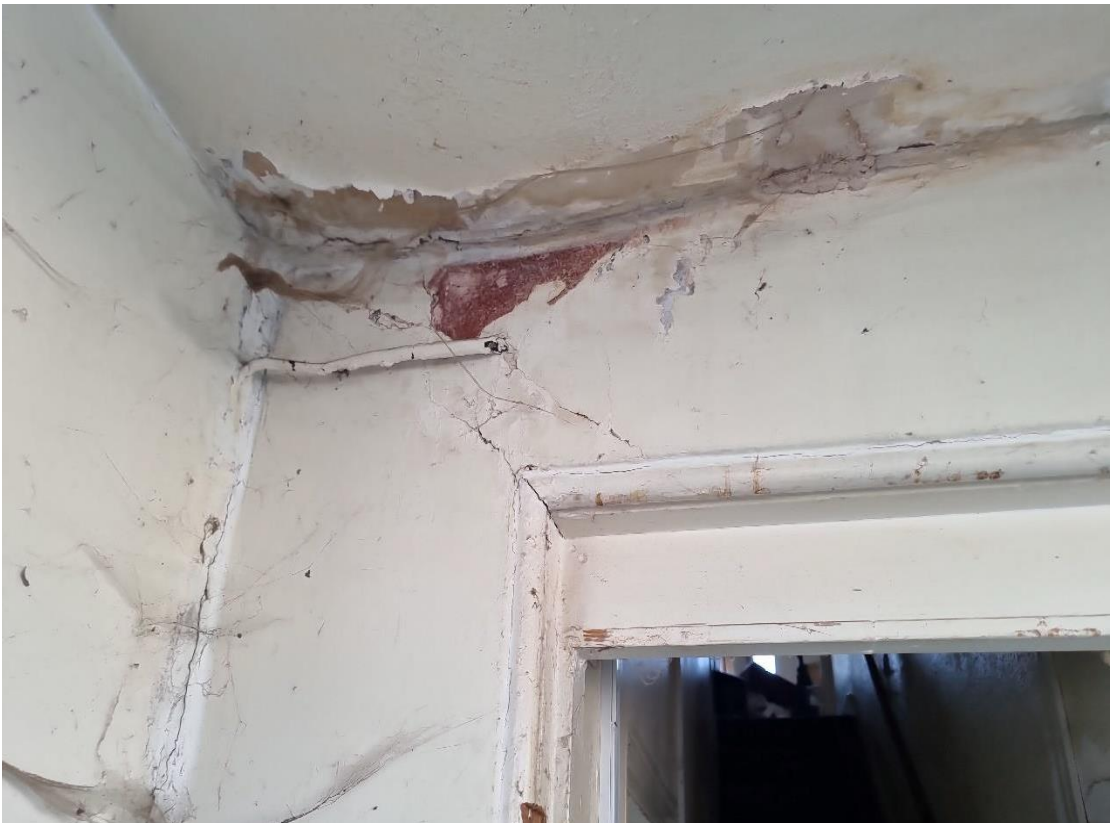
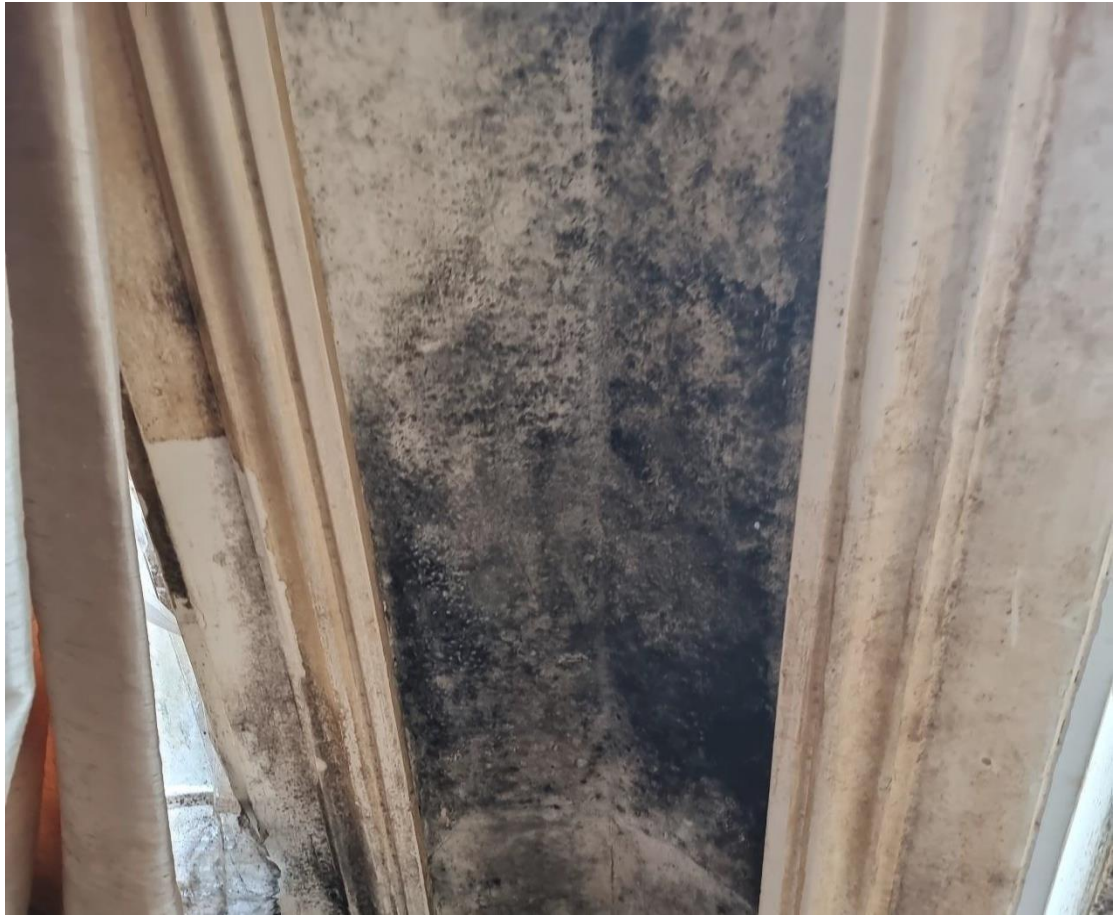
Before

The standard was particularly poor but after the intervention of the EH team significant improvements were made and the property could be licensed.

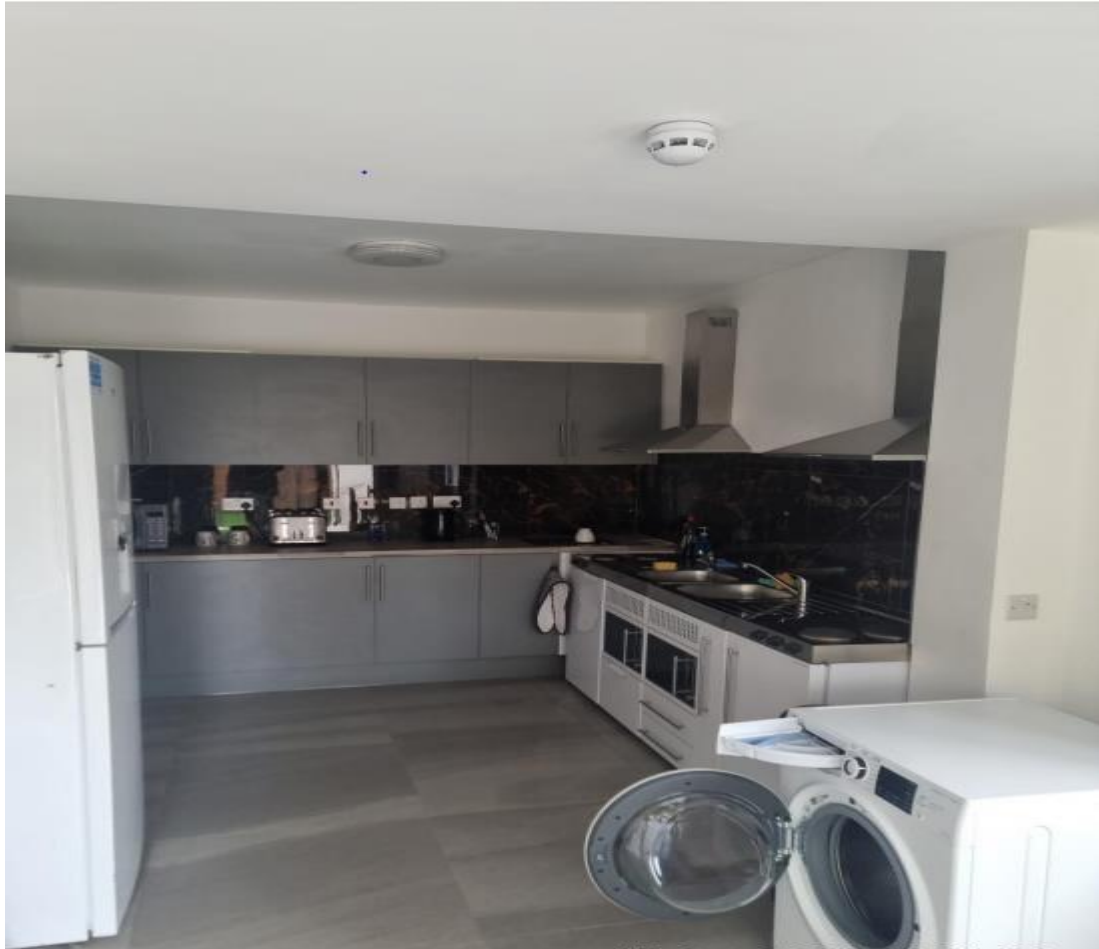
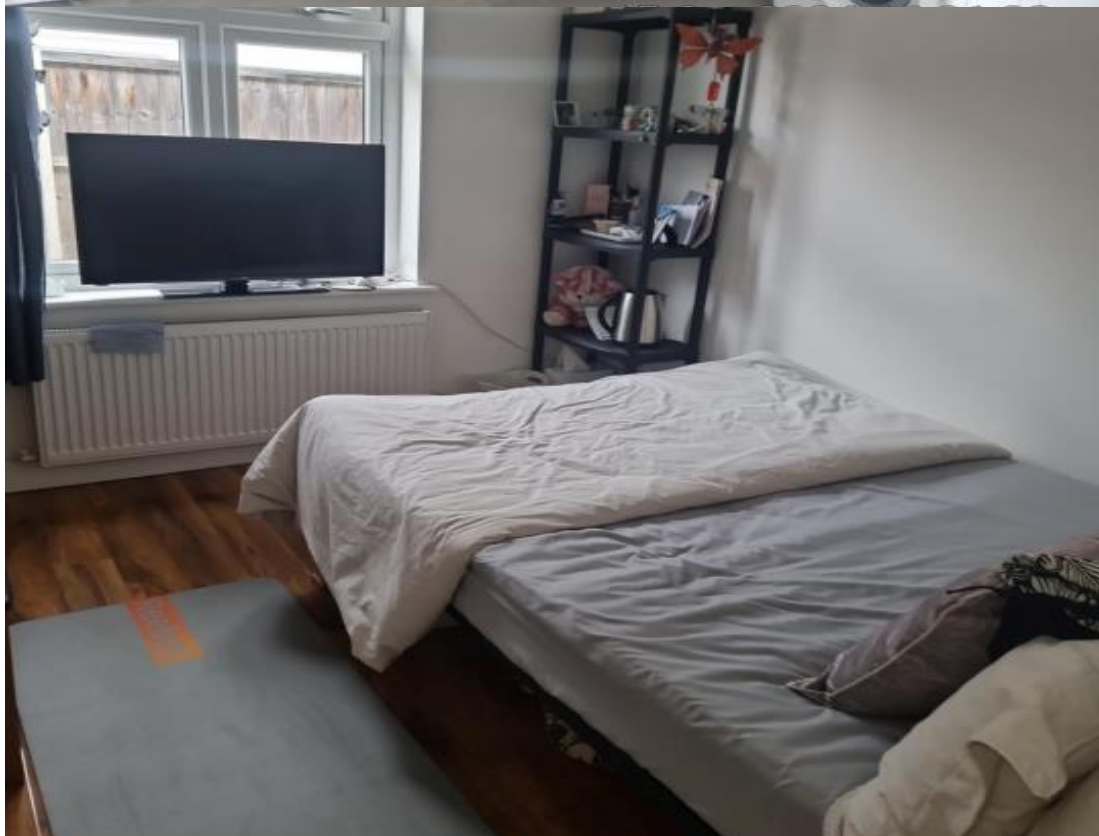
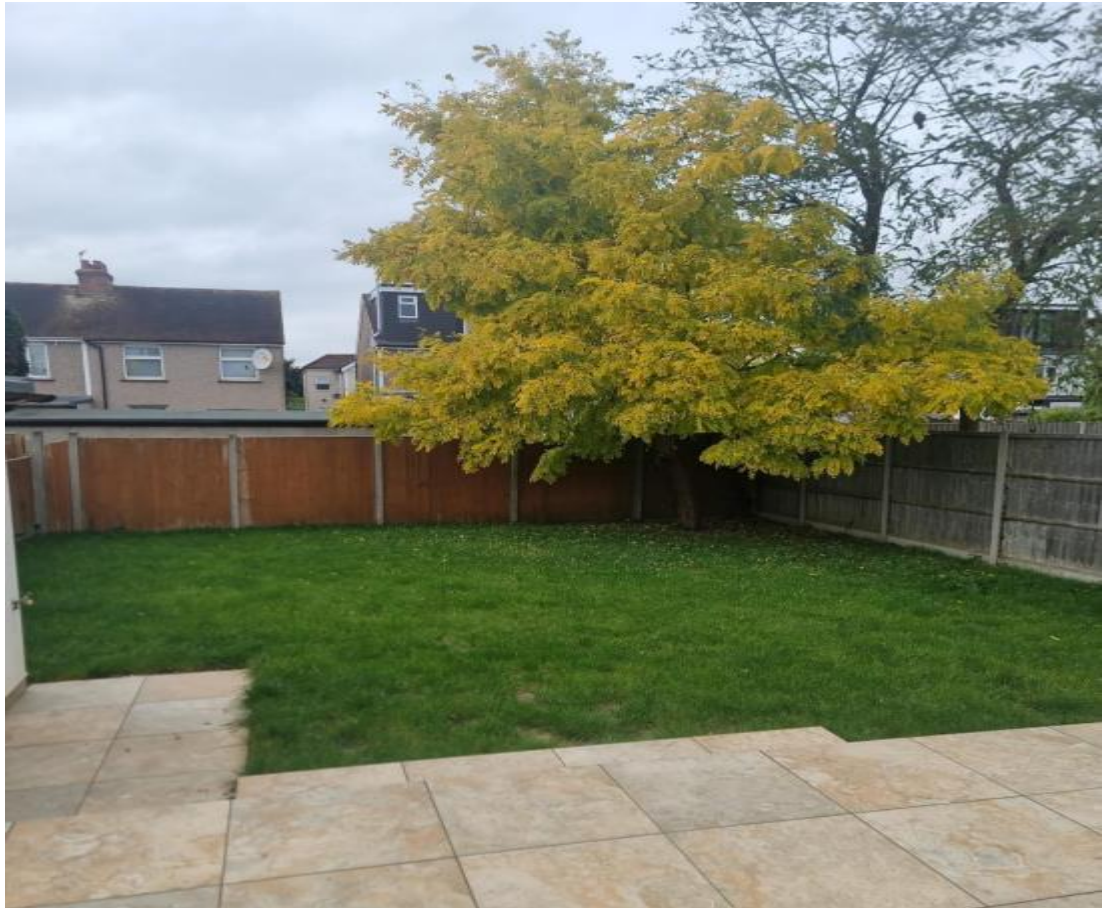
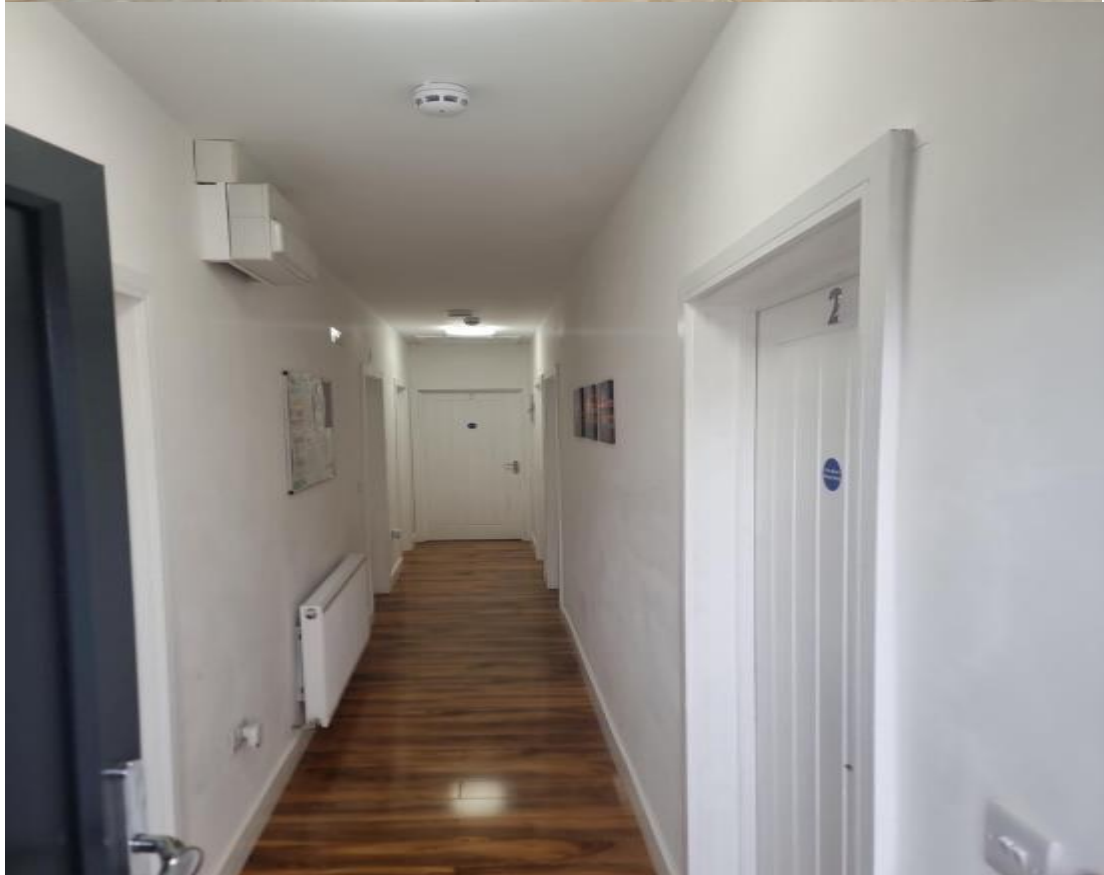
Second Property – good standards
