Thames Valley Surveying

9 December 2025

**34 Kingston Road, Staines Upon Thames, Berkshire TW18 4NL - Dampness Defect Inspection**

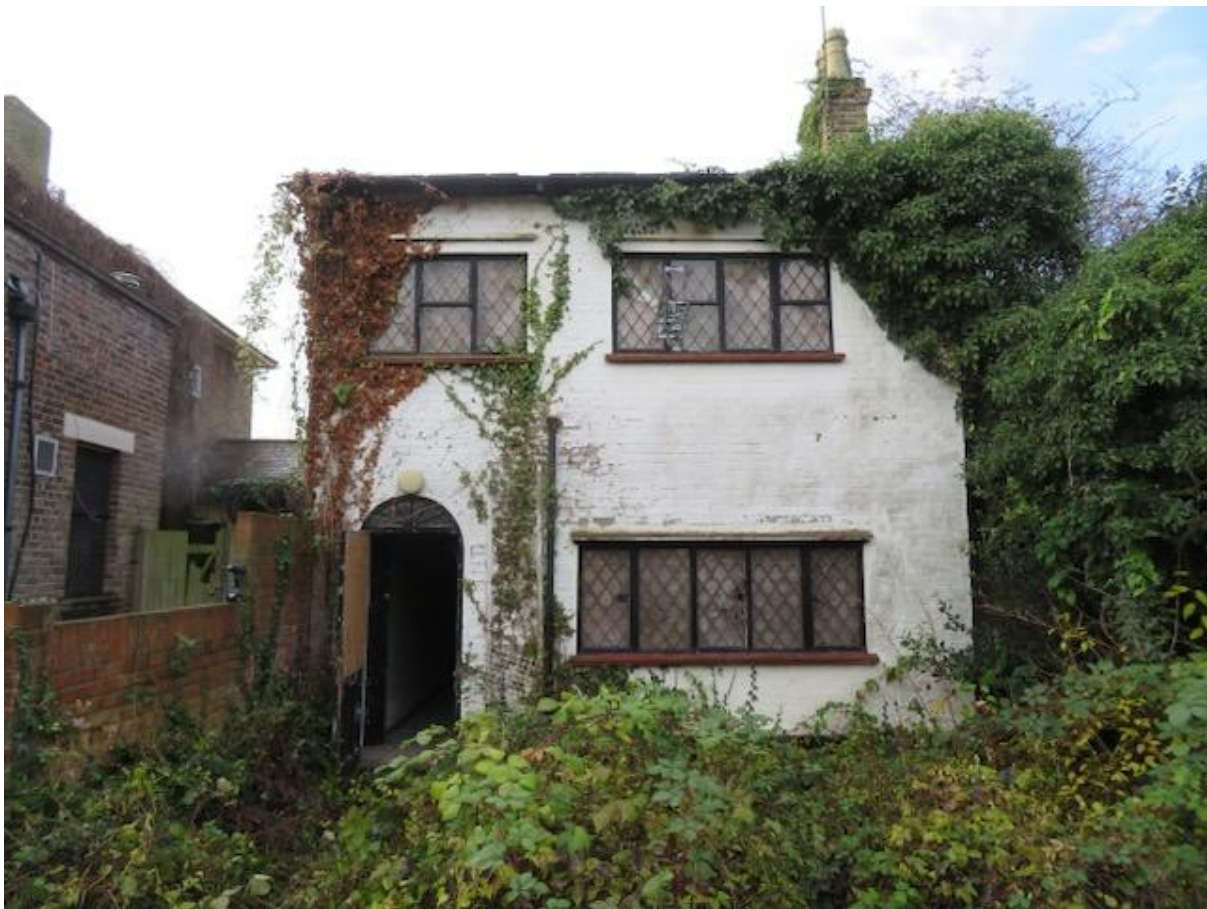
Photo 1- Front Elevation – Overgrown External walls

The front garden of the property is heavily overgrown with self-seeded shrubs and garden debris. It may be that there is contaminated material under the plant life, but this could not be determined during our survey. It is generally unsafe underfoot without protective footwear.

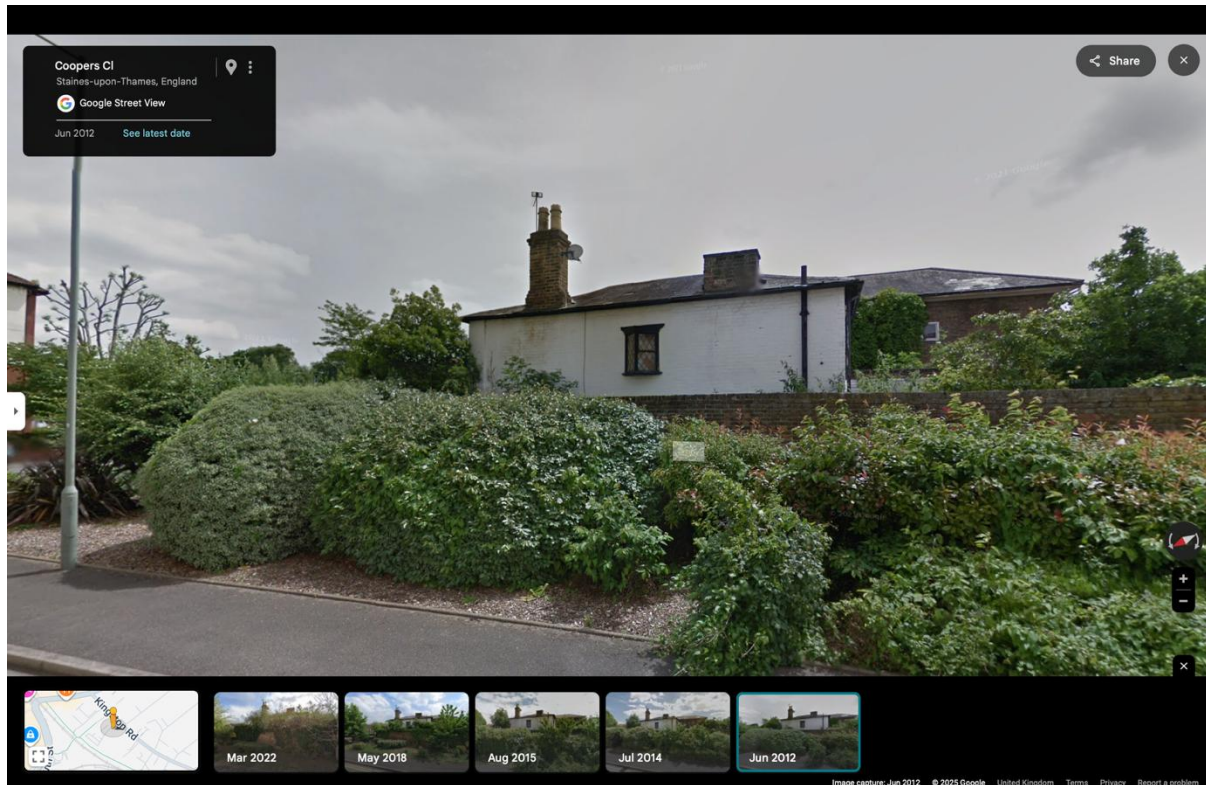
The West elevations runs along Coopers Close. This has a boundary wall that separates the site from the landscaped highway boundary. The landscaping is heavily overgrown. There are large self-seeded shrubs in both the building and the boundary wall. The lack of landscape management appears to have been occurring for many years. The picture below is from 2012. The wall is unsafe.

Photo 2- West Elevation – Site in June 2012 - Copyright Google Maps.

The boundary wall now is in poor condition. Several of the upper courses have become displaced by large self seeded plants. The boundary wall will require partial demolition and reconstruction.

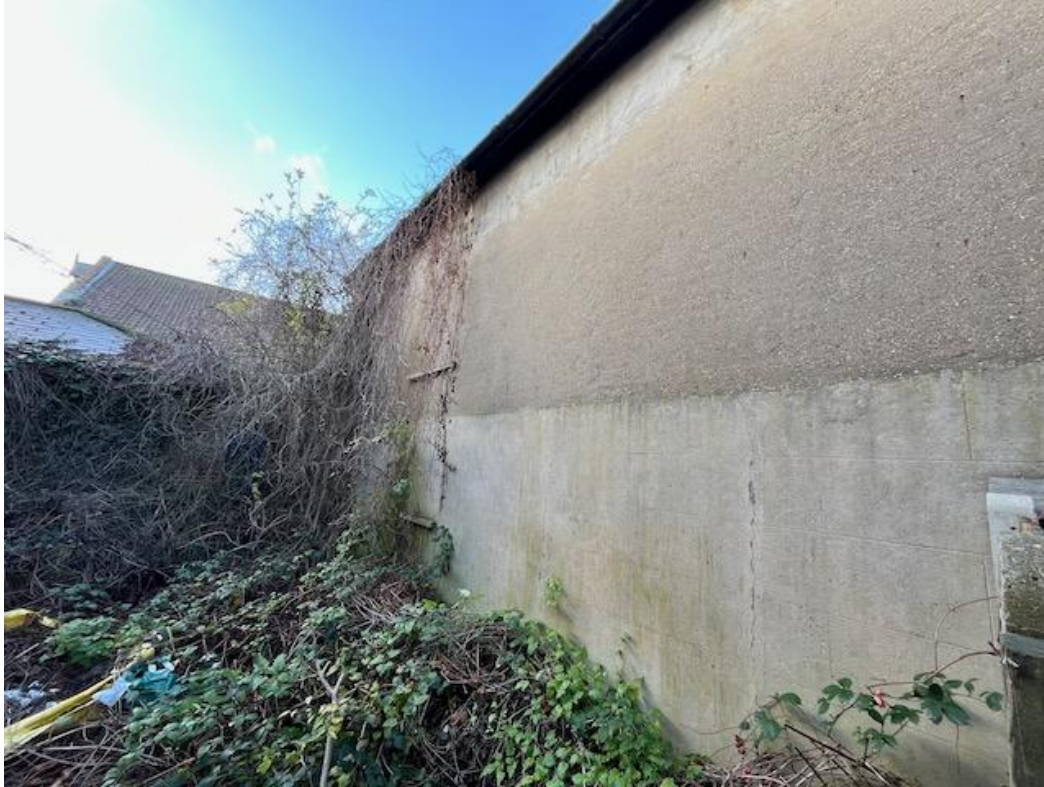
The rear wall of the house is in a fair condition for its age. Like the other main walls it has had no repair, maintenance or decoration for many years and this has led to its deterioration. If it is to be retained it will require pointing repair and wholesale redecoration at minimum. The inset windows and doors will also require overhaul/ replacement.

Photo 3 - Cracked render overgrown with shrubs

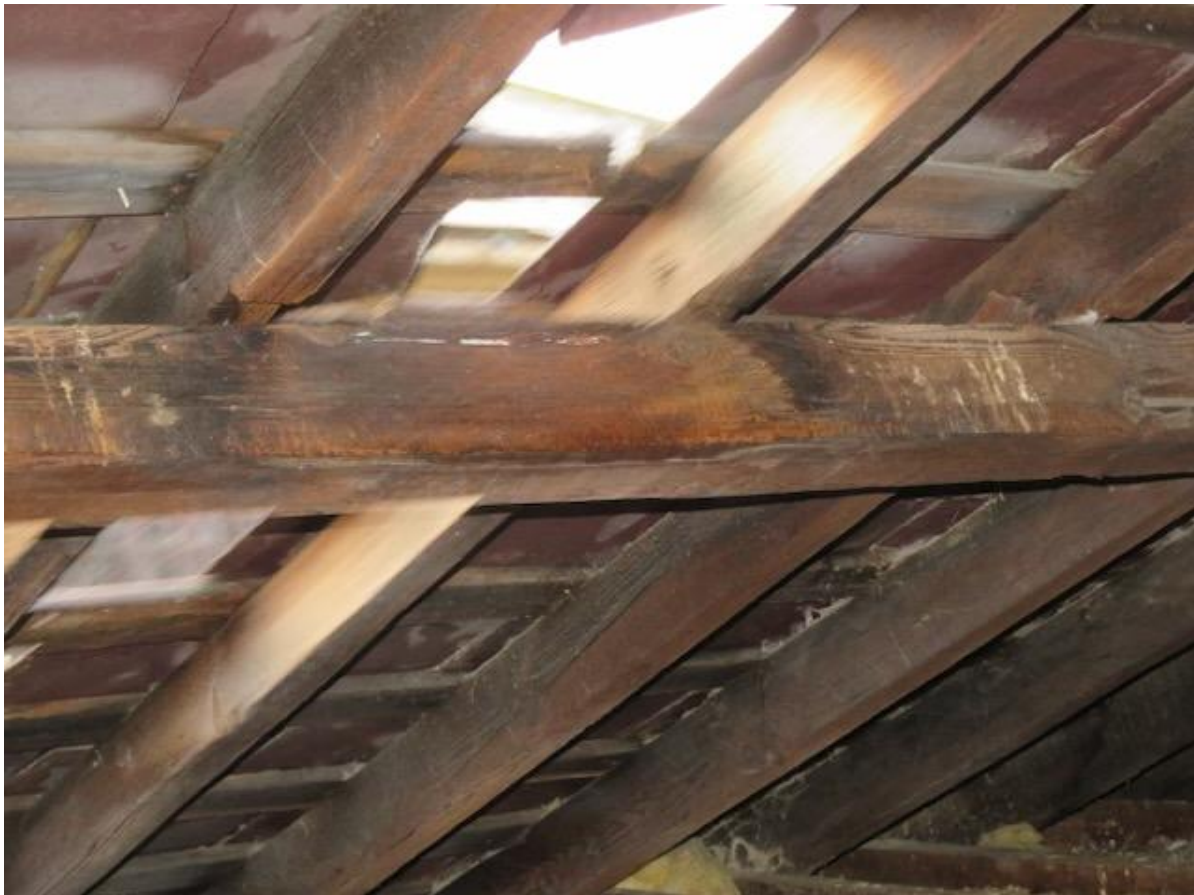
The roof slate covering is missing in no fewer than 5 places. One of these holes is in excess of 600mm by 600mm. The holes in the roof have been present for a number of years.

Photo 4- Holed Roof timber structure

The holes in the roof have and continue to let a large volume of water into the structure. The holes in the roof have also allowed a flock of pigeons to roost within the building for many years. The pigeons first roosted within the loft space. When the ceiling of the loft space collapsed into the first floor the birds were able to roost throughout the building.

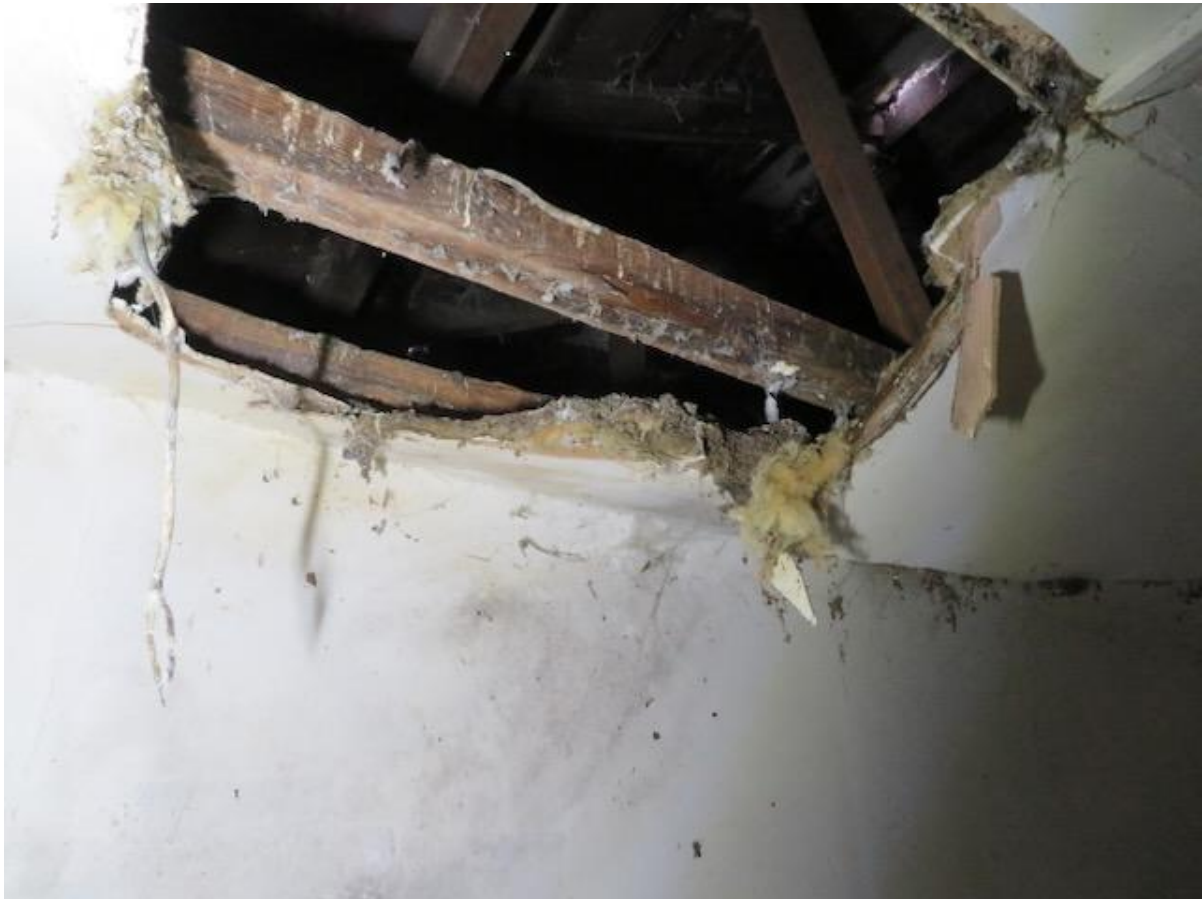
The birds have contaminated the loft space with guano more than 25mm deep in most areas. This sits on top of the original nail fixed timber lathes that support the plaster first floor ceiling. Pigeon guano is known to be extremely acidic as well as toxic. The guano has over time rotted the nail fixings of the first-floor ceiling. The ceiling has partially collapsed in several areas. In the remainder the guano obscures the lathes condition. The whole of the first-floor ceiling will require removal and

Photo 5- Collapsed first floor ceiling

replacement. All the pigeon guano will require removal from the loft space. This would need to be undertaken by a contamination specialist before any attempt to repair the roof could commence.

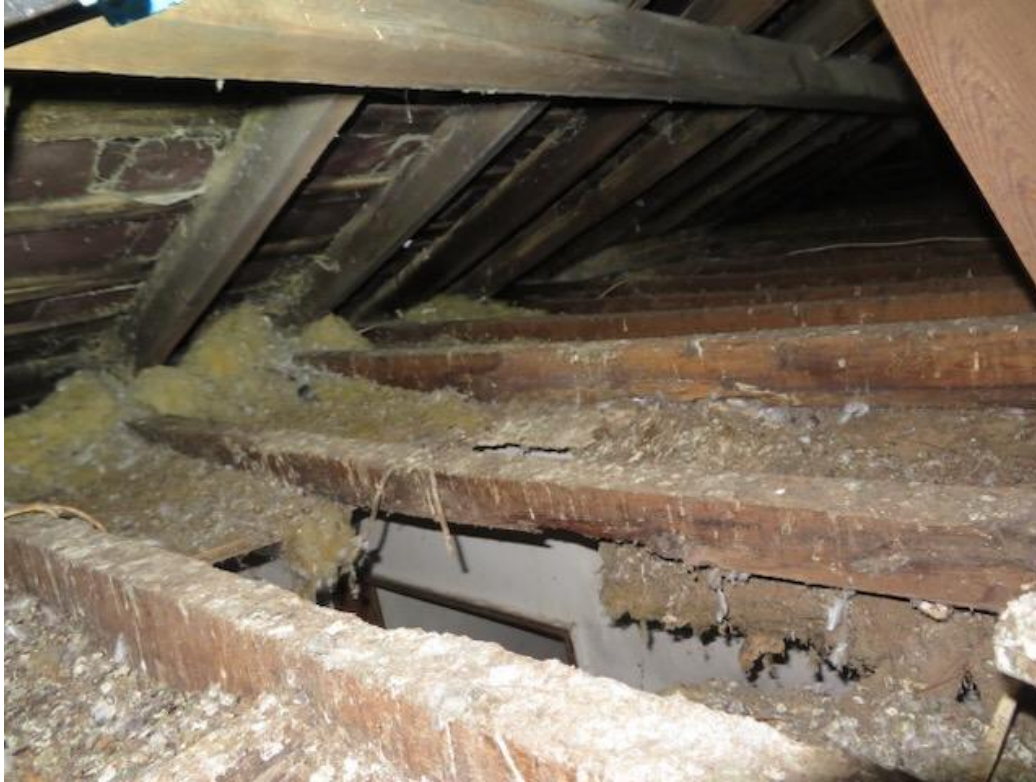
Photo 6- Guano covered timbers above collapsed first floor ceiling

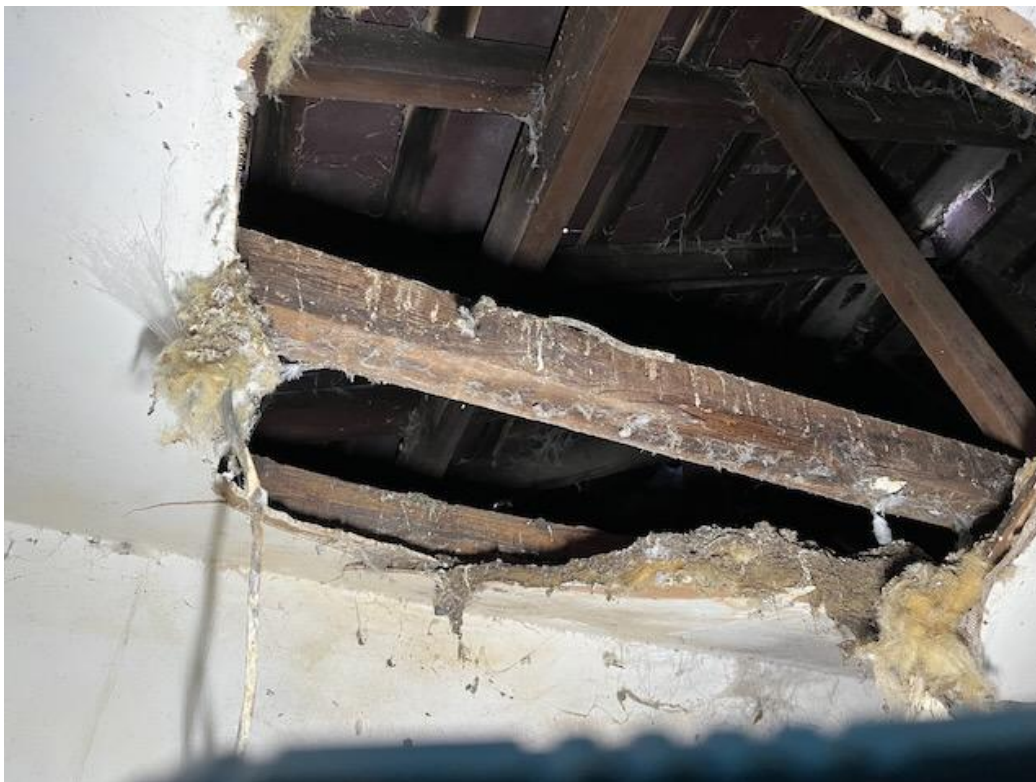
Photo 7- Guano covered timbers above collapsed first floor ceiling

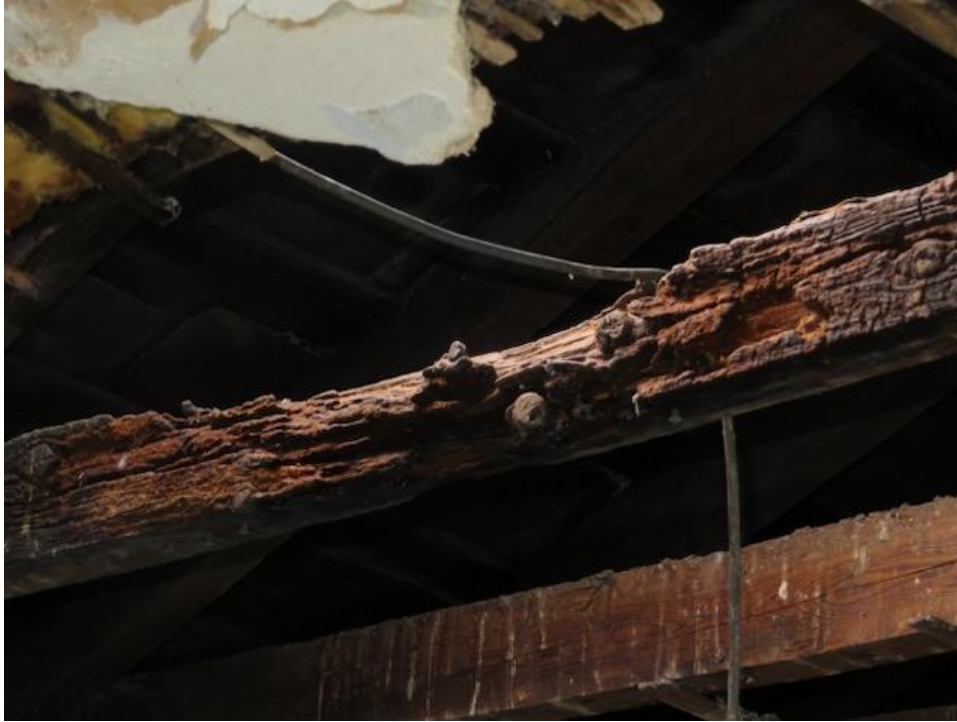
The water ingress through the roof has together with the guano softened the roof timber ties. These ties form the bottom of a triangle that ties together the two sides of the roof slope. With the failure of the ties the roof has started to spread outwards. This can be seen as cracking at the top of the external walls.

Photo 8- Rotted through roof tie

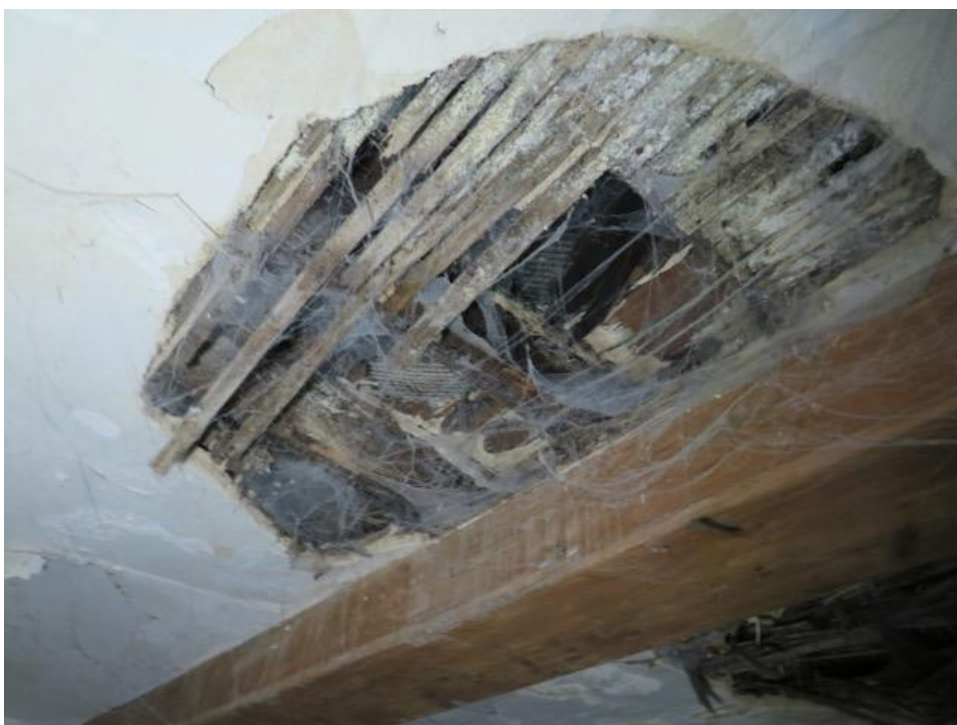
The carpet of pigeon guano continues on the first floor where again the average depth is 10mm with a maximum depth of 25mm. This has had a similar effect of causing the collapse of part of the ground floor ceiling.

The water ingress has also rotted parts of the first-floor timber floor structure including decking, structural joists and ceiling. Parts of the first floor have already collapsed and other areas are soft underfoot.

Photo 9- Guano covered timbers above collapsed ground floor ceiling

In order to repair the first floor, structural propping will be required as the integrity of the first-floor joists cannot be assured.

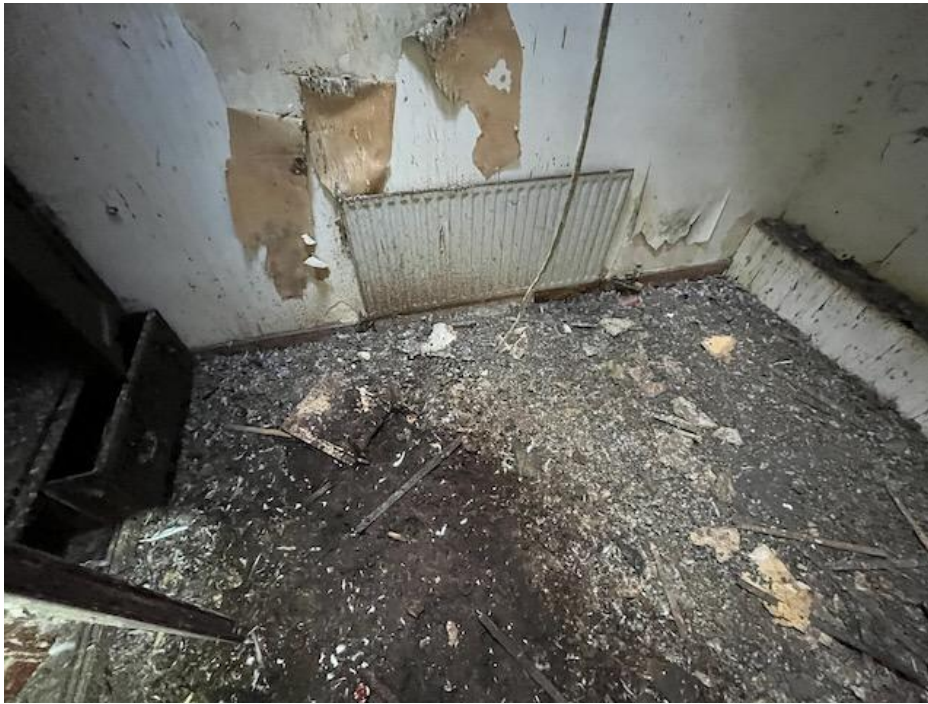
Photo 10- Guano covered first floor finishes

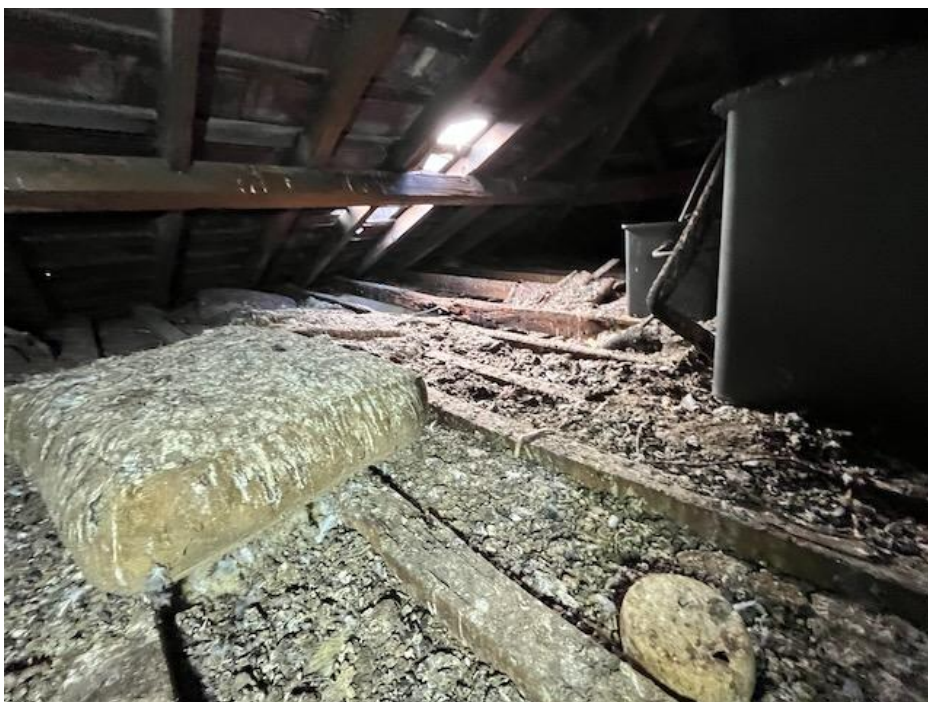
Photo 11- Guano covered timbers above collapsed first floor ceiling

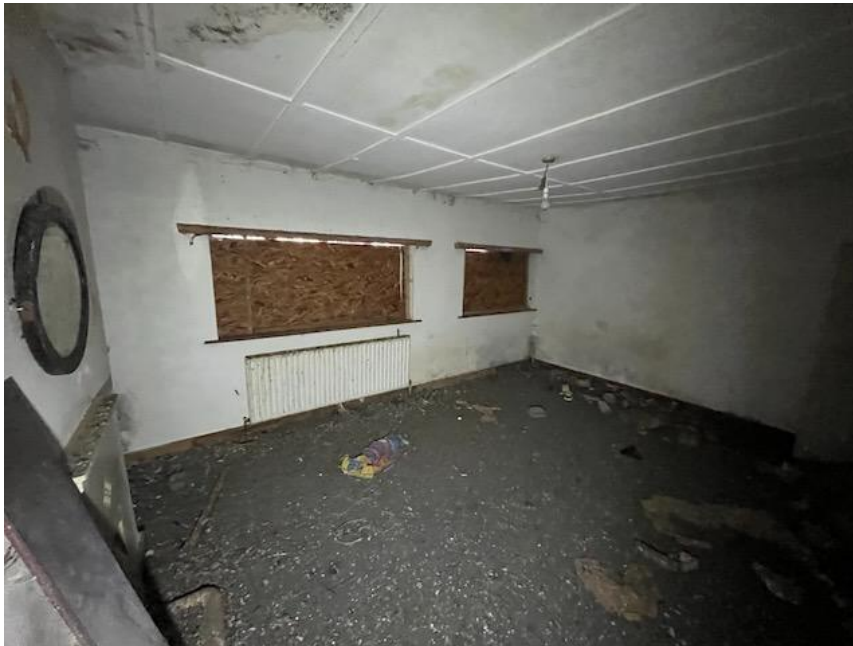
The windows at the property are all in need of replacement. Around 50% are completely missing with just bare brick openings evident. In others older single glazed steel frames are evident but the glazing is boarded over externally.

Photo 12- Missing windows

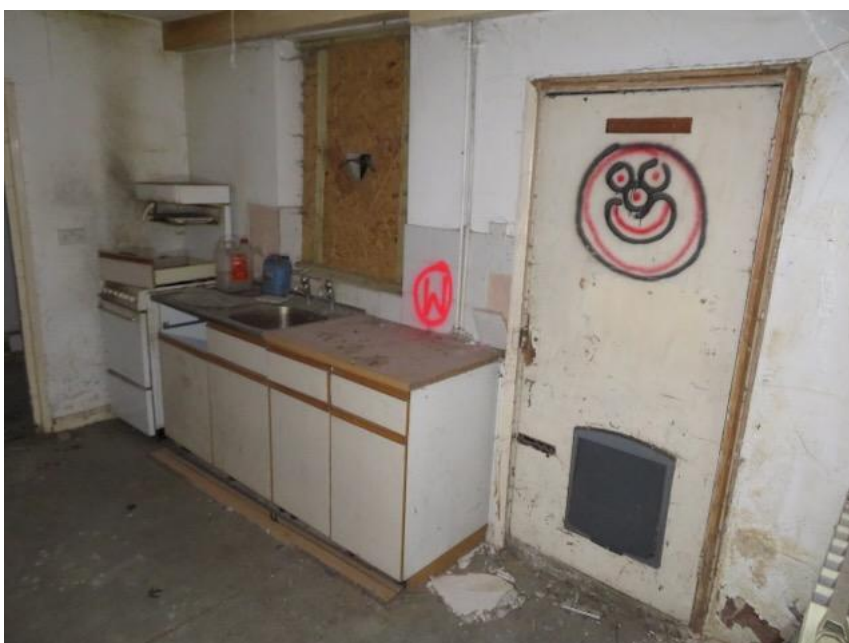
The kitchen at the property is also now derelict, guano covered and would require complete replacement.

Photo 13- Guano covered derelict kitchen

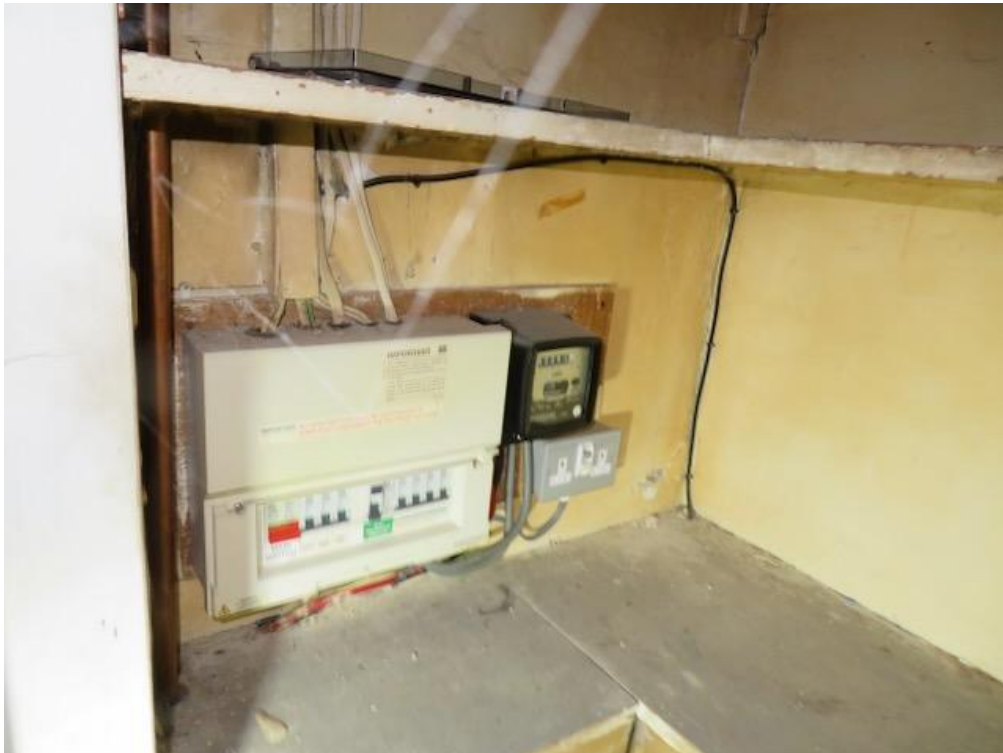
*Photo 14 – Electrical meter and consumer unit.*

The property has a 100 amp single phase electrical supply. The supply is still live and a meter is fitted. Extreme caution should be taken within the building as there is a real risk of electrocution and death.

The property is unsafe due to the extensive water ingress and the presence of the guano contamination. We recommend that Scottish and Southern Electricity (SSE) be asked to cut the building off from the mains supply or at the very least remove the mains fuse.

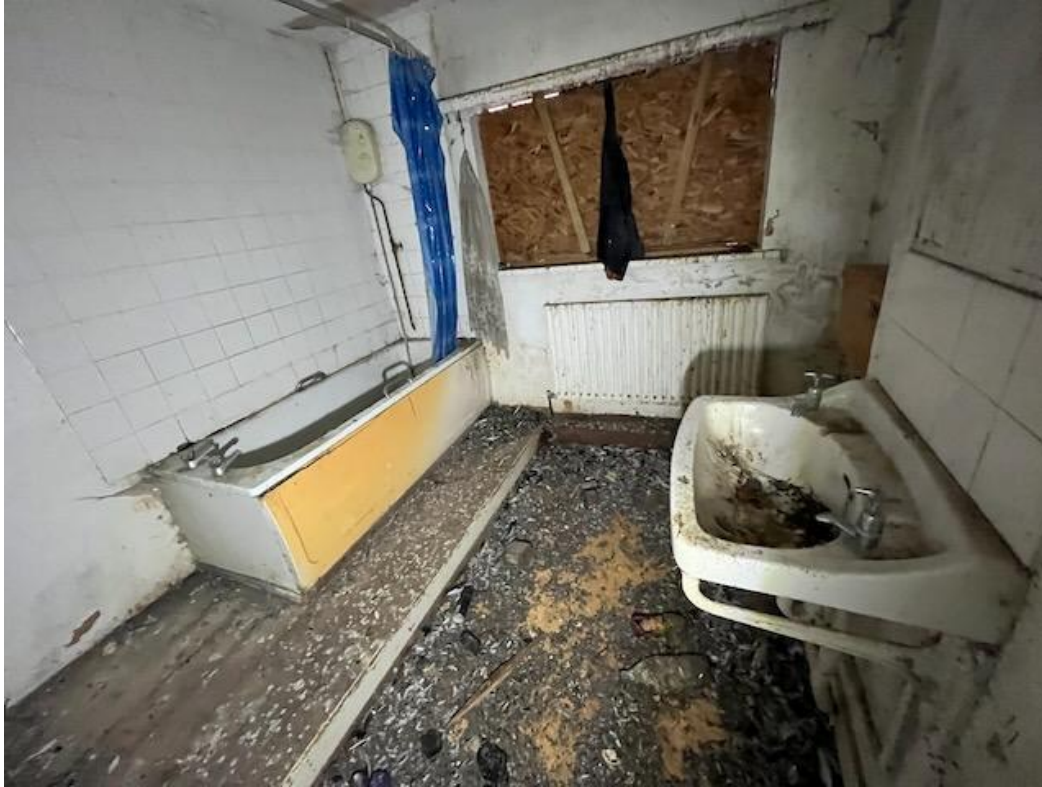
The building has a bath and basin fitted. These are linked to a hot water supply. There is an electric over bath shower unit. All the fitting are contaminated with guano and will require replacement.

Photo 15- Guano covered bathroom fittings
