Watercourses in Spelthorne

This document contains all information relevant to the various watercourses within the Borough of Spelthorne. This includes general information, flooding information, biodiversity status, recent history and a continually updated account of each watercourse. Additionally, it contains information of riparian responsibility of Spelthorne Borough Council.

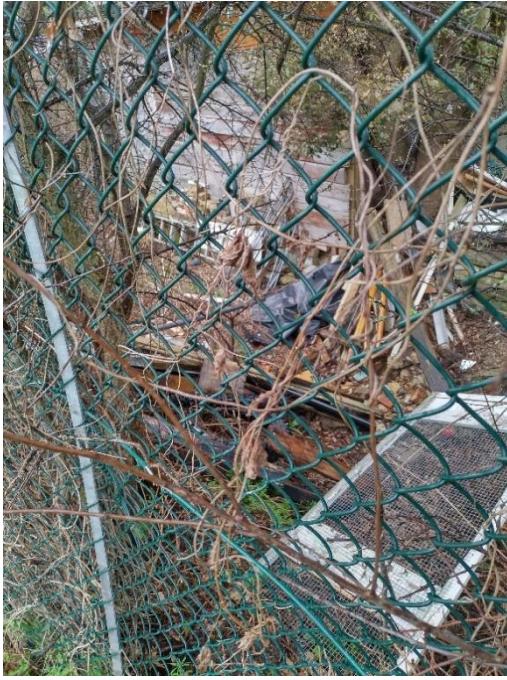
The Feltham hill brook is a deep, almost permanently dry channel. The channel is found full of litter and municipal waste from the adjacent dwellings that back onto the brook.

Images of Feltham Brook from Kenyngton Manor park

SBC Riparian Ownership	Inspection/responsibility	Notes
Groveley recreation ground	3 x Annually	Large, deep channel, almost permanently dry. Inspect mainly for litter - tri-annual litter clearance at Groveley by back entrance.
Kenyngton Manor Park	Annual Inspection

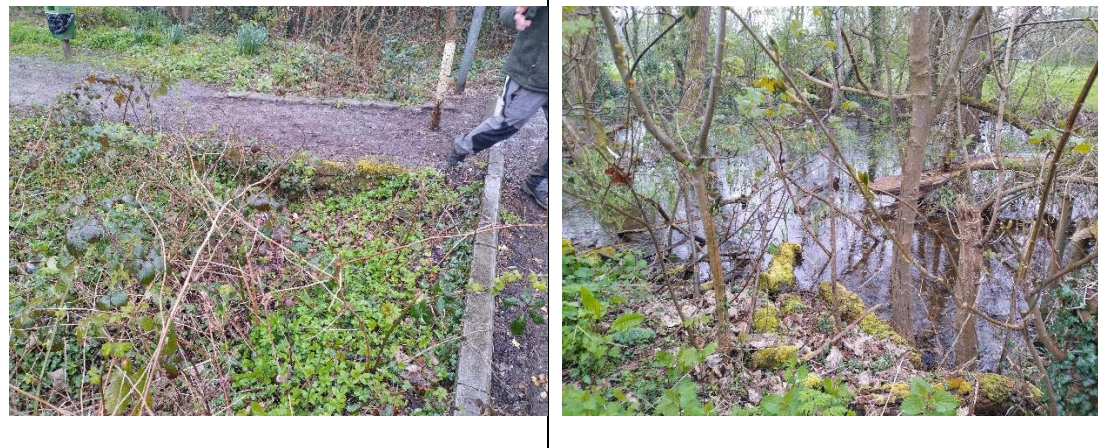
Images of Manor Park section of Black ditch bordering cricket ground entrance

SBC Riparian Ownership	Inspection/responsibility	Notes
Manor Park	Annual Inspection	These are to be inspected annually and require occasional litter clearance and vegetation clearance from the channel.
Russel Road Grass Verges	Annual Inspection

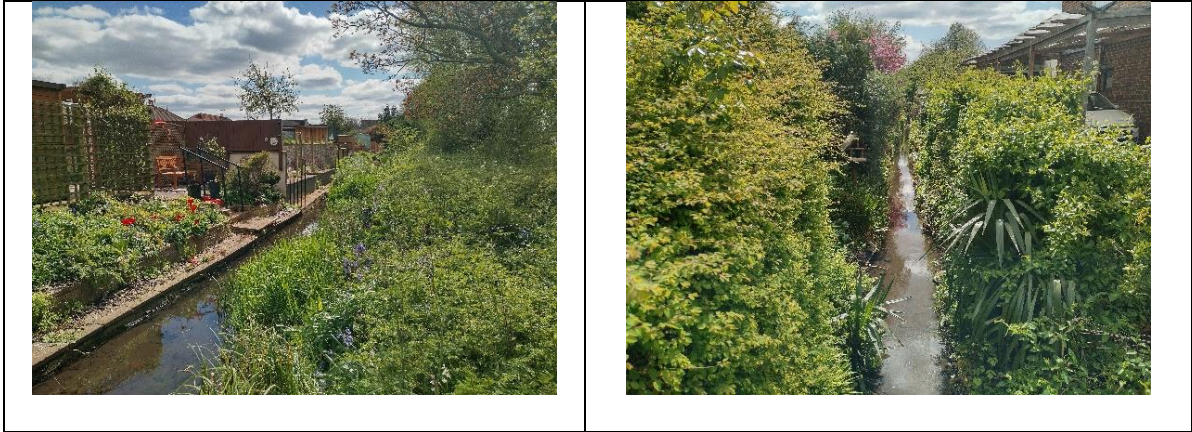
Image of upper section of Sweeps Ditch on Gresham Road	Image of mouth of Sweeps Ditch where it meets the Thames at Penton Hook lock

Sweeps Ditch as seen from the East side of Staines Park	Sweeps Ditch passing between Kingtsbridge Crecent and Nursery Gardens

Riparian Ownership	Inspection/ responsibility	Notes
Staines Park	4 x annually	Focus areas: litter can build up between bridge to main park up to near the health centre; channel by Commercial Road bridge is also a dumping spot; Vegetation growth in channel where it borders back of Farm Close properties can require annual clearance; Reed growth by bridge to main park can require annual cut back; Pinch point in channel behind pond feature can get dammed by kids. Health Centre area is Surrey CC responsibility -

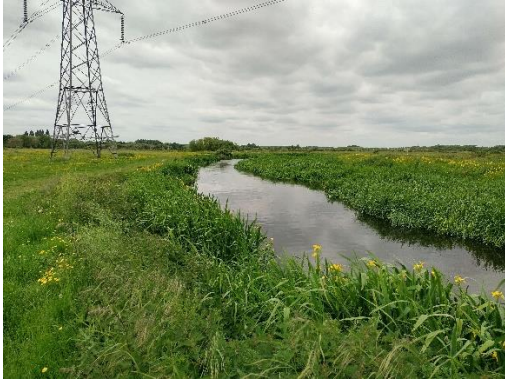
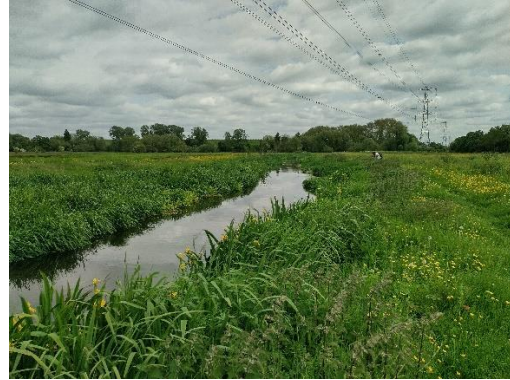
River Colne as seen from Staines Moor

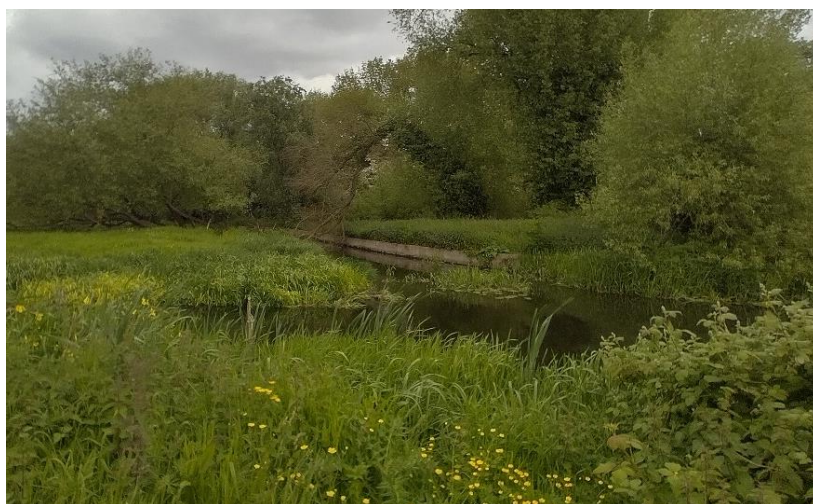
There are currently no flood risk concerns within the borough for Bonehead Ditch.

Bonehead ditch as seen from its mouth with the Colne

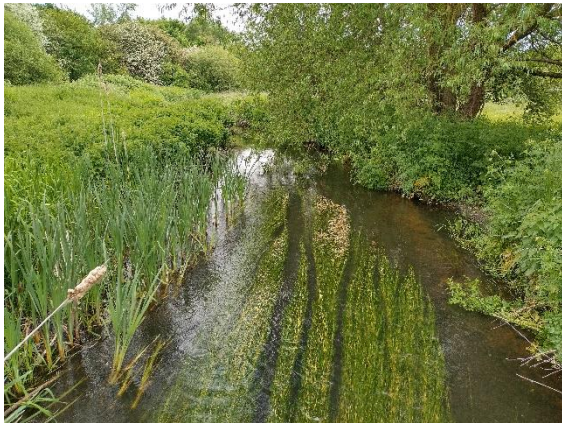
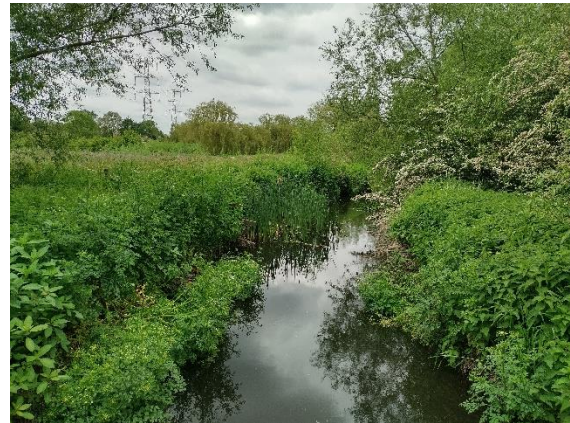
River Wraysbury as seen from Staines Moor.

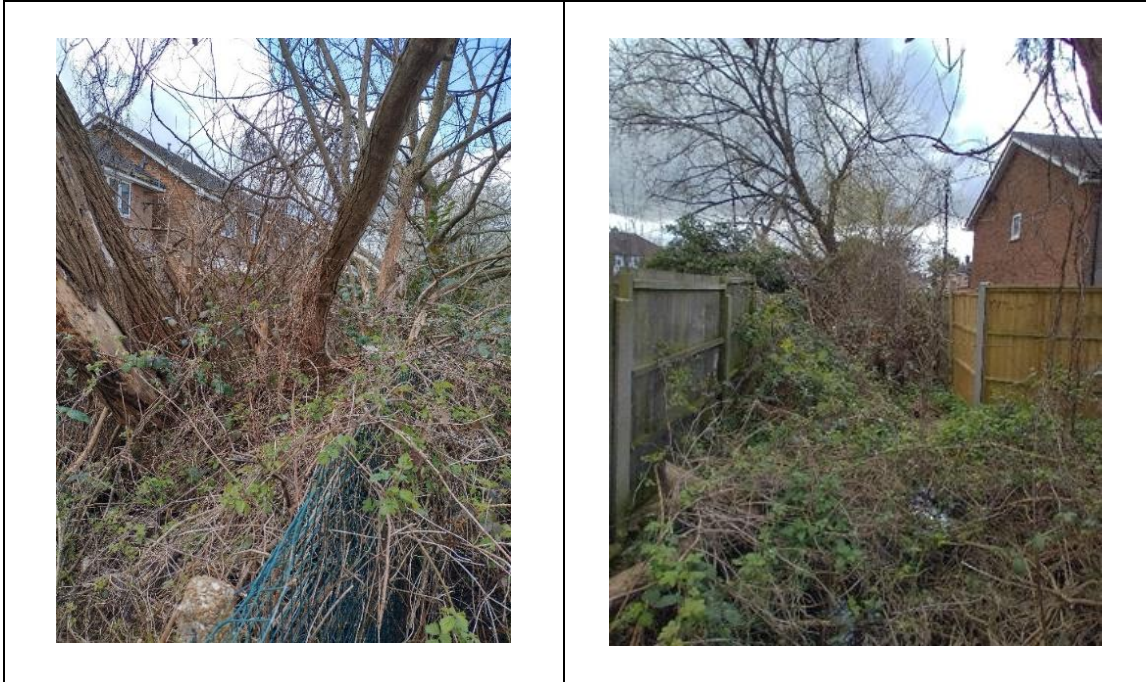
There were issues with flooding in houses and gardens along Long Lane, adjacent to Long Lane recreation ground. It was determined that an underground culvert had become damaged, leading to surface water flooding.

This flooding was focused to areas around a drain that leads from the southern most part of Long Lane recreation ground.

Image of Drain adjacent to long lane recreation ground

There are ongoing conversations with Surrey County Council and the Environment Agency as to how this may be addressed in the future. See below photos for the state of the drain that became flooded.

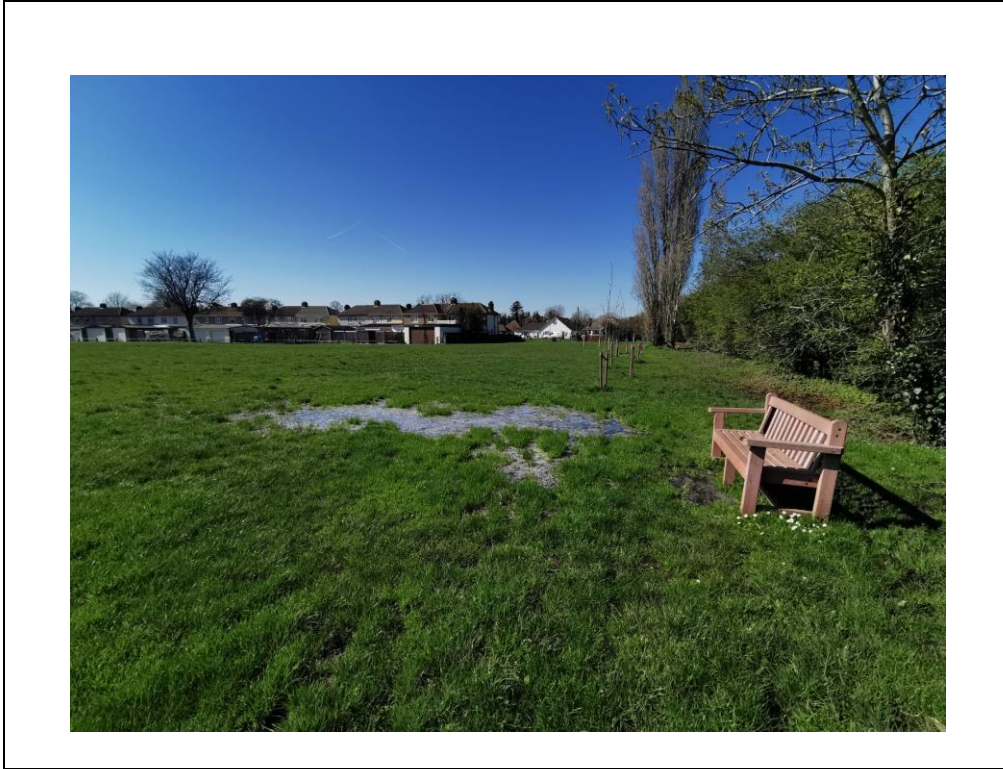
Although there is not a known ordinary watercourse here, there is the presence of a semi-permanent source of water located in the Stanwell Moor recreation ground, on spout lane.

Photo of the water source located in the Stanwell moor recreation ground

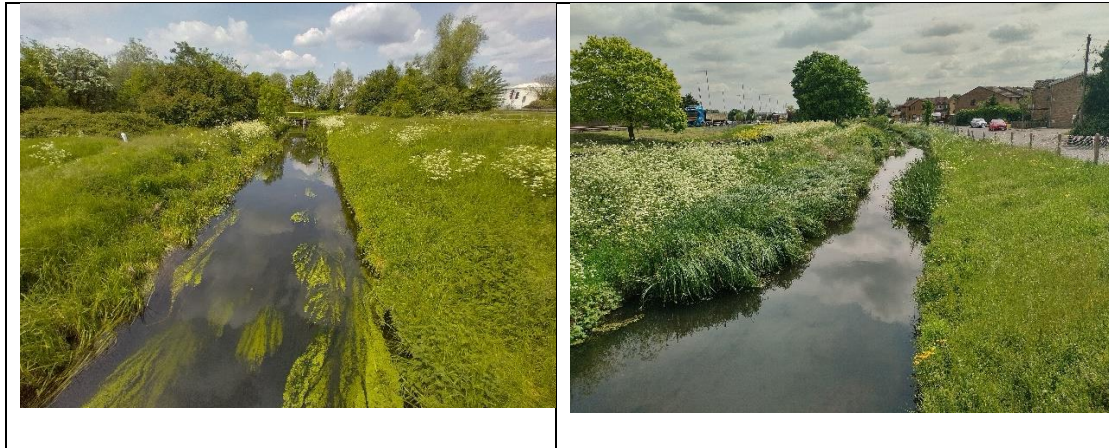
Longford river in north Stanwell
