UPPER HALLIFORD CONSERVATION AREA APPRAISAL APRIL 2024 (DRAFT)

UPPER HALLIFORD: CONSERVATION AREA APPRAISAL CONTENTS

1.1 Introduction

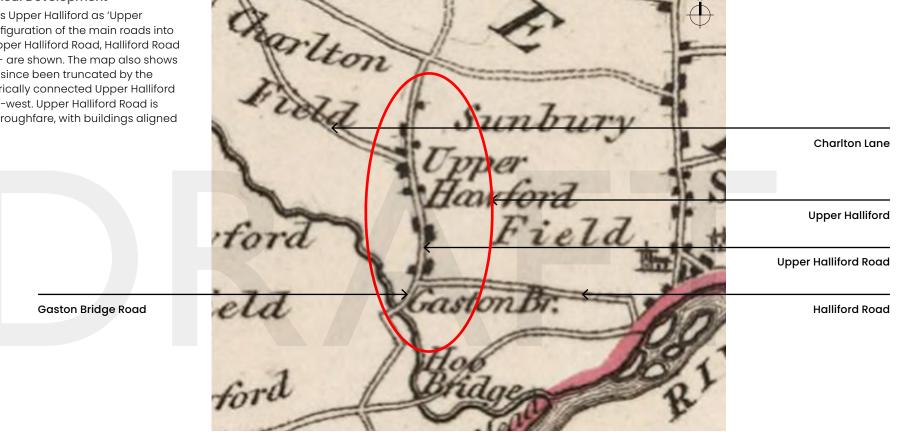
Cary's map of 1801 records Upper Halliford as 'Upper Hawford'. The historic configuration of the main roads into and out of the village - Upper Halliford Road, Halliford Road and Gaston Bridge Road - are shown. The map also shows Charlton Lane, which has since been truncated by the Halliford Bypass but historically connected Upper Halliford with Charlton to the north-west. Upper Halliford Road is recorded as the main thoroughfare, with buildings aligned on either side.

Upper Halliford as shown in John Cary's map, 1801.

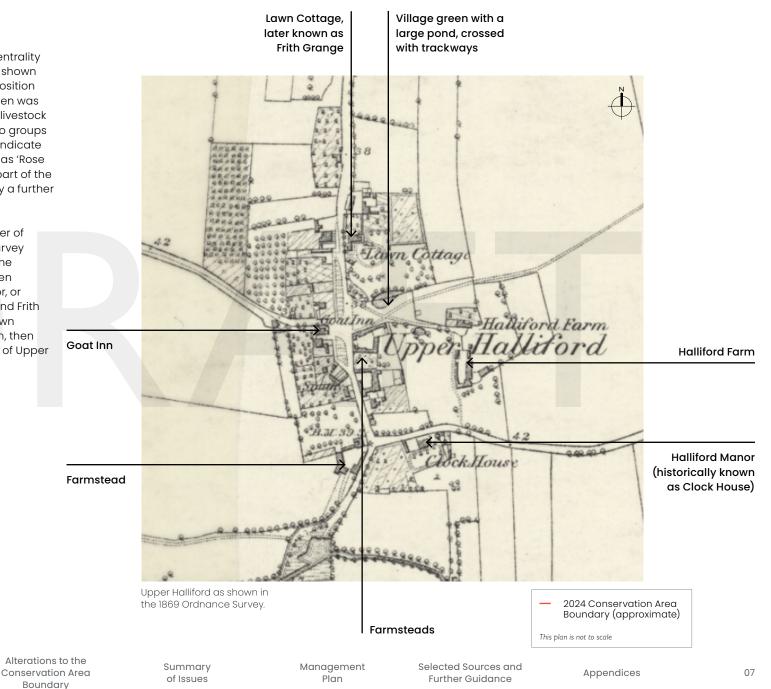
The 1869 Ordnance Survey illustrates the historic centrality of the village green to Upper Halliford. The green is shown to have been crossed with trackways in a similar position to the current access roads. To the north of the green was a pond, presumably used for watering horses and livestock from the surrounding farms. South of the green, two groups of structures arranged around central courtyards indicate the site of historic farmsteads. The dwelling known as 'Rose Cottage' at 14 Upper Halliford Road was originally part of the southern farmstead. To the far east of the green lay a further farmstead known as 'Halliford Farm'

As well as illustrating the rural, agricultural character of 19th-century Upper Halliford, the 1869 Ordnance Survey also demonstrates that the village had attracted the construction of substantial dwellings in private, often landscaped grounds. These include Halliford Manor, or 'Clock House' as it was then known (18th century) and Frith Grange (19th century), identified on the map as 'Lawn Cottage'. The map shows the 18th-century Goat Inn, then occupying a much smaller footprint, on the corner of Upper Halliford Road and Charlton Lane.

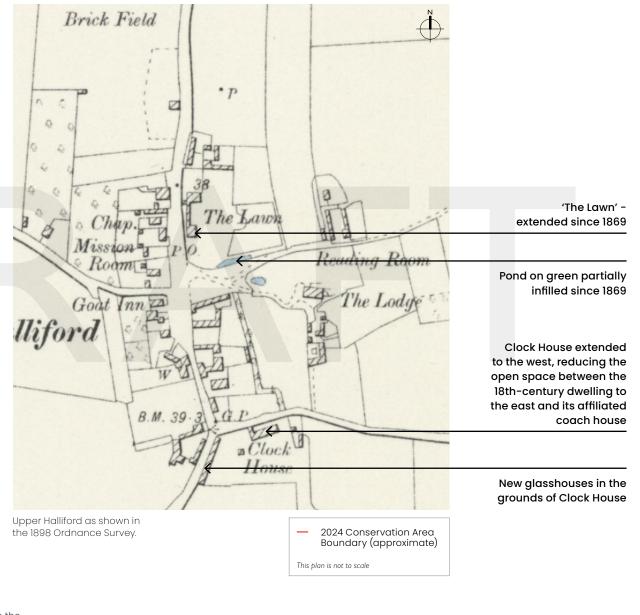
Changes evident in the Ordnance Survey of 1898 include the construction of Halliford Manor House, between Halliford Manor and Clock Cottage (the former coach house for the earlier dwelling). All three properties are shown in the 1898 Ordnance Survey as one estate known as 'Clock House', which shows the 19th-century addition was conceived as an extension rather than a separate residence. New glasshouses had been constructed in the grounds of the house, on the boundary with Gaston Bridge Road.

The pond straddling the boundary of the village green and the grounds of 'The Lawn' (later Frith Grange) had been partially infilled. 'The Lawn' had been extended to the south. New residential dwellings had been built on the west side of Upper Halliford Road since 1869.

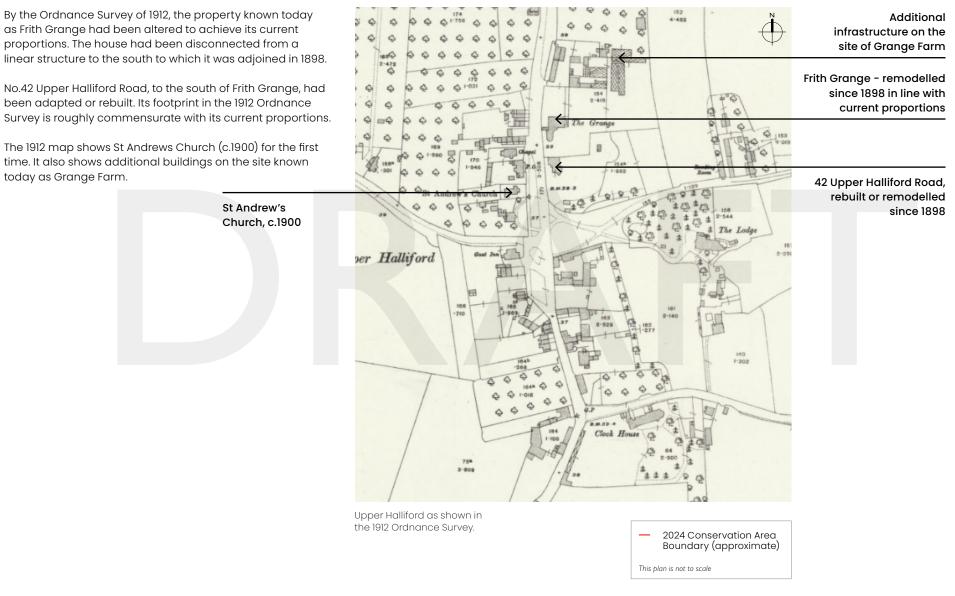
as Frith Grange had been altered to achieve its current proportions. The house had been disconnected from a linear structure to the south to which it was adjoined in 1898.

No.42 Upper Halliford Road, to the south of Frith Grange, had been adapted or rebuilt. Its footprint in the 1912 Ordnance Survey is roughly commensurate with its current proportions.

The 1912 map shows St Andrews Church (c.1900) for the first time. It also shows additional buildings on the site known today as Grange Farm.

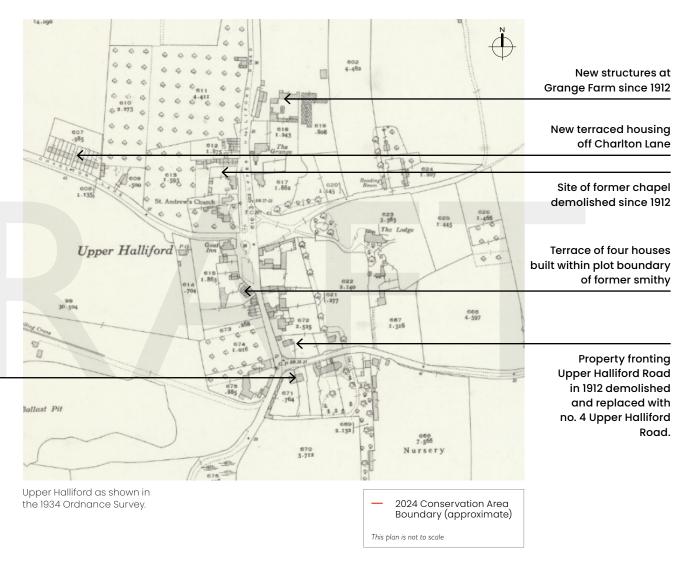
Several changes can be seen in the Ordnance Survey of 1934. New plot boundaries within the grounds of Clock House indicate that the house had by this time been subdivided to provide Halliford Manor, Halliford Manor House and Clock Cottage. A new pair of houses had also been built to the west in the former grounds of Clock House.

A house in private grounds, shown facing onto Upper Halliford Road at the junction with Gaston Bridge Road and Halliford Road in 1912, had been demolished. The plot boundaries had been redrawn and the house had been replaced with the current 4 Upper Halliford Road.

A small terrace of four houses had been erected in the centre of the village, in the grounds of a former smithy which had been demolished since 1912. The map also shows new terraces on Charlton Lane just west of the Conservation Area boundary.

The Goat Inn had been extended, and the infrastructure at Grange Farm, to the north of the village, had continued to develop. A former non-conformist chapel opposite Frith Grange had been demolished since 1912.

> New pair of houses since 1912. Former grounds of 'Clock House' subdivided since 1912

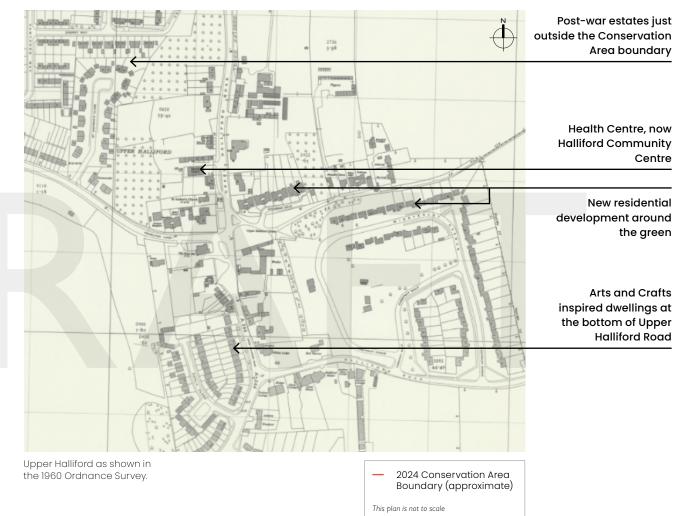
There was much residential development both within and adjacent to the Conservation Area boundary between 1934 and 1961. This included the construction of the four pairs of distinctive mid-20th century houses on the western side of Upper Halliford Road. Residential estates had also been built around the village green.

Since 1961, the former farmsteads on the west side of Upper Halliford Road have been lost and a new estate, Home Farm Close, had been built. The bypass has been constructed since this date.

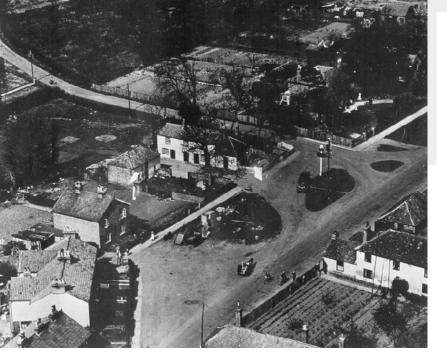
Aerial imagery of Upper Halliford during the 1920s, looking northwest. The wider section of road to the east of the Goat Inn is shown here. The grass verges may represent areas of former common land, around which roads were subsequently formed or expanded. Reproduced with permission of the Sunbury and Shepperton Local History Society.

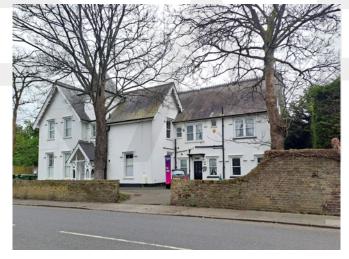
42 Upper Halliford Road, built between 1898 and 1912, illustrates the contemporary fashion for the Tudor Gothic style – with hood moulds over the windows, decorative barge boards, and a strong emphasis on verticality achieved through the steeply-pitched roofs and pointed arches to the front porch.

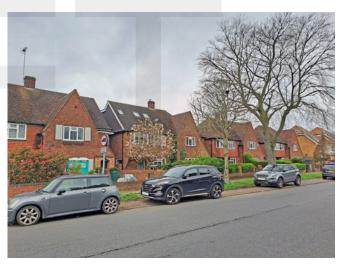
Four pairs of mid-20th century houses on the west side of Upper Halliford Road. The influence of the Arts and Crafts movement can be seen in the asymmetrical roofline, leaded lights, use of richly coloured red brick and decorative hung tiles.

D Inclusion of four pairs of 1950s Arts and Crafts style houses on the west side of Upper Halliford Road which contribute to the eclectic architectural character of the Conservation Area and continued evolution of the village.

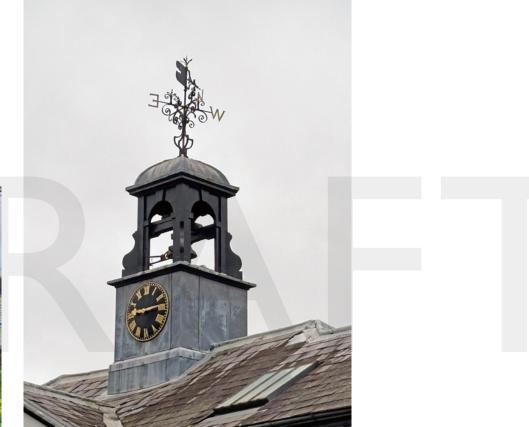
The distinctive lead-covered cupola on Clock Cottage, Halliford Road.

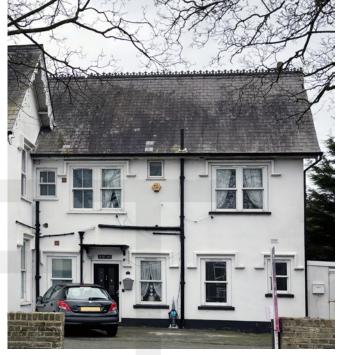
Modern uPVC rainwater goods detract from the aesthetic interest of this principal elevation.

Historic gutters and downpipes have been widely replaced or supplemented with uPVC rainwater goods. In some instances, modern downpipes are inappropriately placed, cutting across highly visible elevations and detracting from their aesthetic interest.

- Where seeking to improve failing modern features, a traditionally-designed alternative using appropriate materials is preferable. For example, the replacement of uPVC gutters and downpipes with lead, cast iron or coated aluminium alternatives that better reflect the traditional character of the Conservation Area.

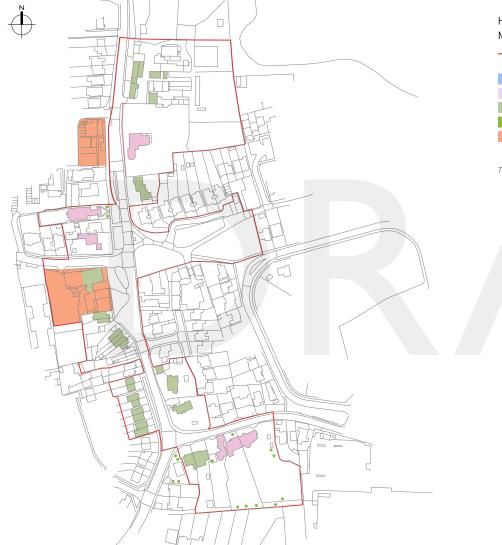
HERITAGE ASSETS AND Measures MANAGEMENT OPPORTUNITIES In order to p

2024 Conservation Area Boundary
 Listed Building
 Locally Listed Building
 Positive Contributor
 Tree Preservation Order
 Opportunity for Enhancement
