SHEPPERTON CONSERVATION AREA APPRAISAL MARCH 2024 (DRAFT)

SHEPPERTON: CONSERVATION AREA APPRAISAL

SECTION 1.0: INTRODUCTION

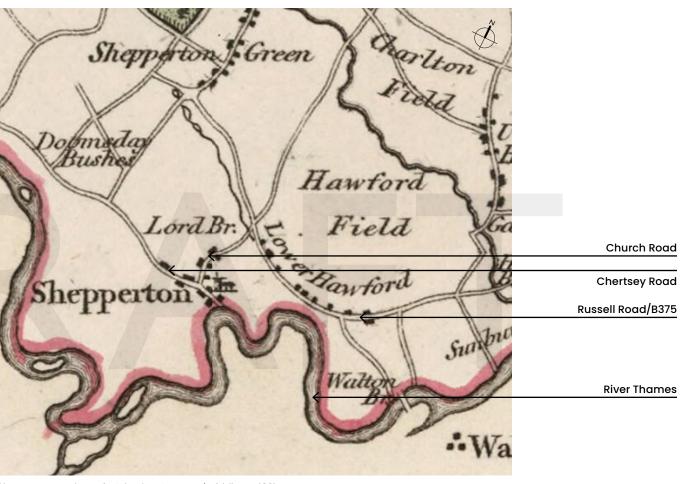
Cary's map of 1801 shows the small rural settlement of Shepperton, centred on the early 17th-century Church of St Nicholas. The River Thames supported trade and industry in the village. In the 17th century Shepperton was a recognised barge halt and in the early 19th century it was the headquarters of several owners of barge horses. However, proximity to the river brought threats as well as opportunities; the medieval church, which had been sited eastwards of its current location, was swept away by flooding in the 16th century.

Cary's map shows the distinctive crank of Church Road, which records suggest may be a later thoroughfare diverted inland during the 15th or 16th centuries, on account of erosion to the previous route between Shepperton and Lower Halliford.

Shepperton as shown in John Cary's map of Middlesex, 1801.

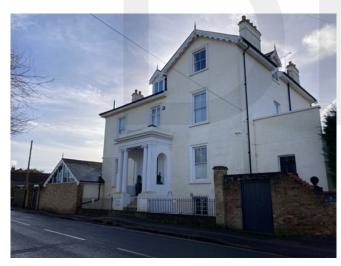
The regular fenestration and grand doric portico at Mill Eyot are typical Neo-Classical features. The wavy-edged bargeboards and finials are however more reminiscent of the 19th-century Gothic revival. Mill Eyot was built in the mid-19th century when Gothic was beginning to eclipse Neo-Classical as the dominant architectural style.

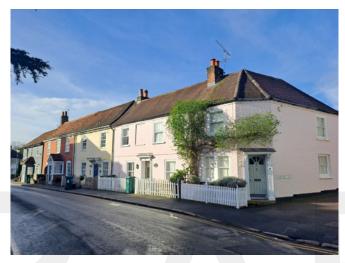
A terrace of Grade II listed 18th-century houses on Church Road. Typical 18th-century features include the regular arrangement of sash windows, small flat-roofed porches supported by scrolled brackets and dentils under the eaves (to No. 2 Lime Tree Cottages).

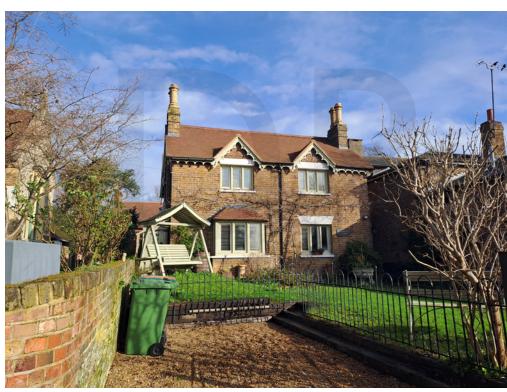
Old Ferry Cottage, Ferry Square. The scalloped bargeboards and tall patterned chimney pots are vernacular inspired features.

No.1 Church Square and Winches Cottage are also vernacular buildings, built using local materials without regard for formal architectural fashion. They contrast visually with the more unified aesthetic of the 18th and 19th-century buildings and give a flavour of how the village may have appeared in earlier times. 19th-century and more recent buildings also incorporate vernacular features including Old

Ferry Cottage off Ferry Square, the hung tiles to the first-floor façade of The Courtyard on Chertsey Road and the steeply pitched roof with leaded dormer lights to the later-20th century house known as Tancredi on Church Road.

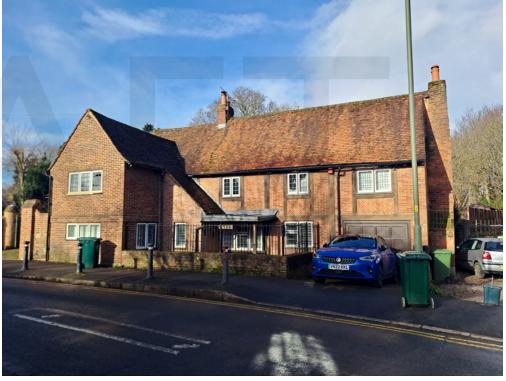
The Grade II listed Winches Cottage on Church Road, a vernacular building with a late 16th-century timberframed core clad in 17th-century brick.

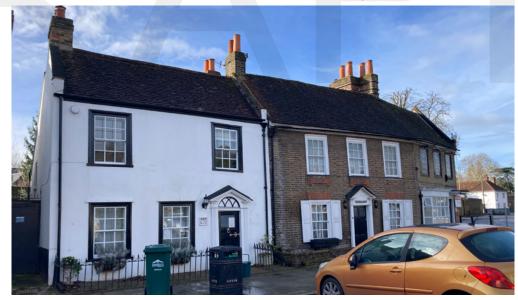
Historic timber-framed sash windows to the 18th century buildings on the south side of Church Square.

The older buildings in the Conservation Area generally retain historic timber sash or casement windows and historic doors, although a small amount of uPVC replacement is evident. Such replacements are conspicuous by their disproportionately thick frames and false glazing bars. Doors are predominantly timber and are mostly panelled and glazed, with some incorporating or sitting under a fanlight. Most replacement doors are traditionally styled.

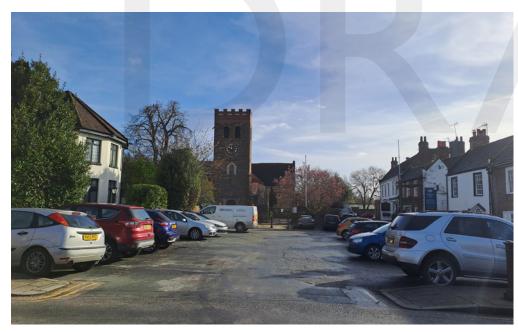
Church Square, the historic core of the Conservation Area and enclosed on three sides by historic buildings.

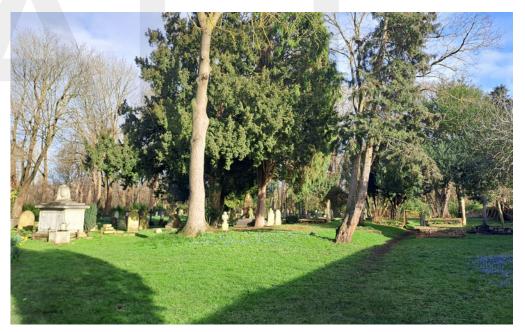
Shepperton Cemetery, the principal green space in the Conservation Area.

The other important open space in the Conservation Area is the cemetery, accessed from Cemetery Lane. It is an informal, heavily treed green space split into several different areas by historic brick walls and level changes. The cemetery, by its nature, has a tranquil, contemplative atmosphere. Several graves are of interest including the prominent tomb of William Herbert Lindsay, owner of the manor estate in the 19th century.
