LOWER HALLIFORD  
CONSERVATION AREA APPRAISAL  
MAY 2024

# LOWER HALLIFORD: CONSERVATION AREA APPRAISAL

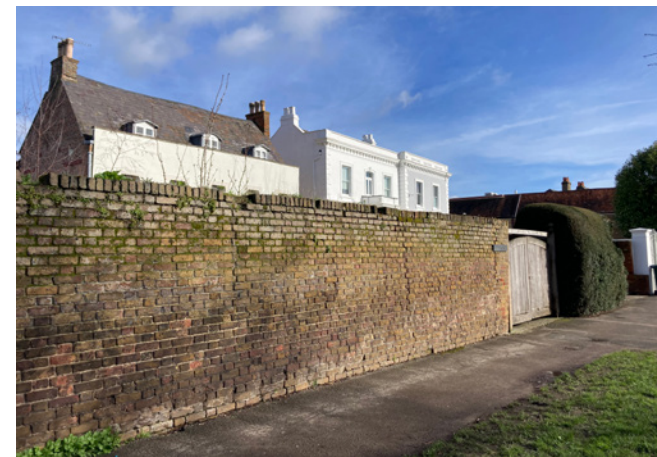
From left to right: Clonskeagh, Willow House and Willow Bank: early 18th, early 19th and late 19th-century Neo-Classical residences on the north side of Russell Road, set back behind a high brick wall.

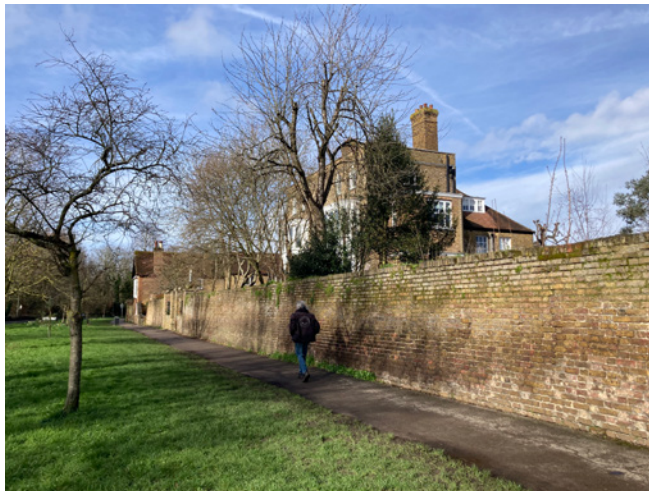
Thamesfield House, a substantial 18th-century residence in the west of the Conservation Area on Russell Road. Dense planting and a high brick wall partially obscure the property from the public walkway. The narrow stretch of green open space north of the road creates an additional sense of separation between the house and the road.

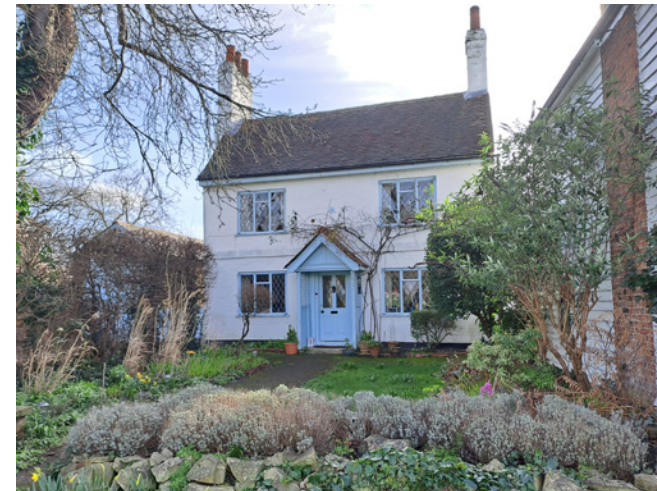
Elmbank Cottage, an 18th-century house incorporating parts of a 16th-century forge in the oldest part of the Conservation Area, which fronts onto Lower Halliford green. The low boundary walls create a sense of connection between the house and the green, which was the nucleus of the medieval settlement.

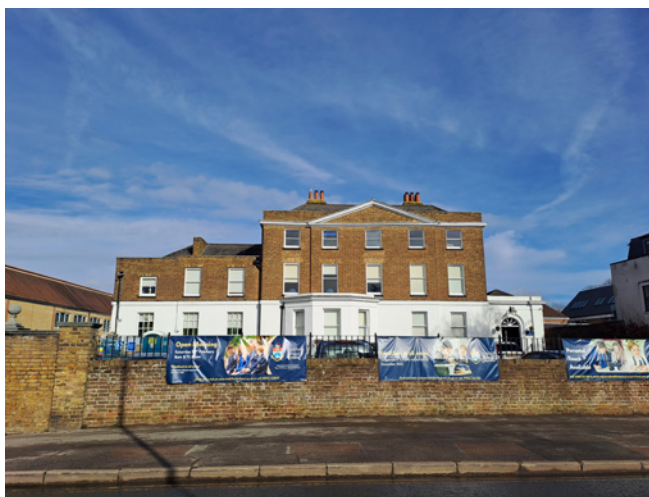
Halliford School, originally built as a house in the late 18th-century. The building is typically Georgian in its use of restrained Neo-Classical decoration, with symmetrically arranged sash windows under flat arches, a plain eaves cornice, a simple pediment, and a parapet.

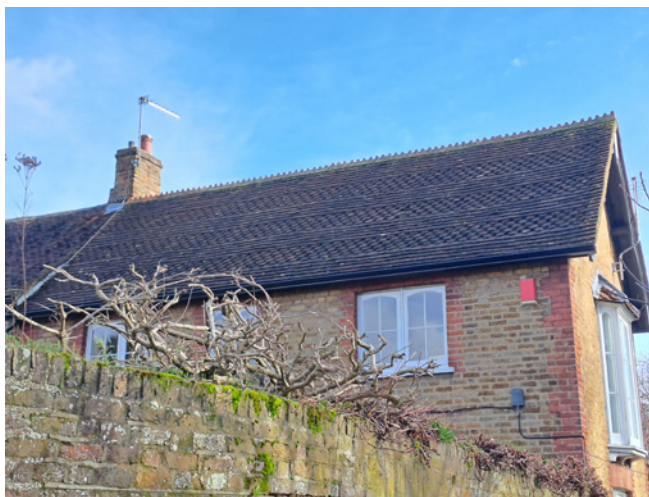
Decorative clay tiles to the roof of the Grade II listed Thamesfield Cottage on Russell Road.

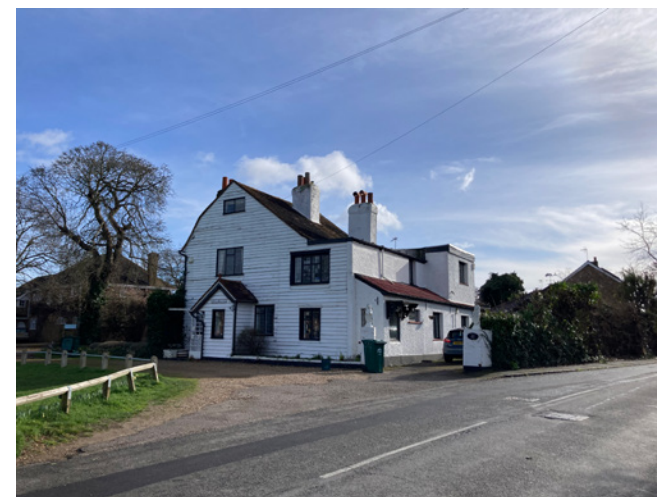
This building constitutes two cottages, the oldest phase to the left having been first built as a barn in 1720. Its irregular roofline, timber weatherboarding and windows of mixed styles and proportions identify it as a vernacular structure. The partial survival of the barn, incorporated into a later dwelling house, evidences the agricultural economy which sustained Lower Halliford for most of its history.

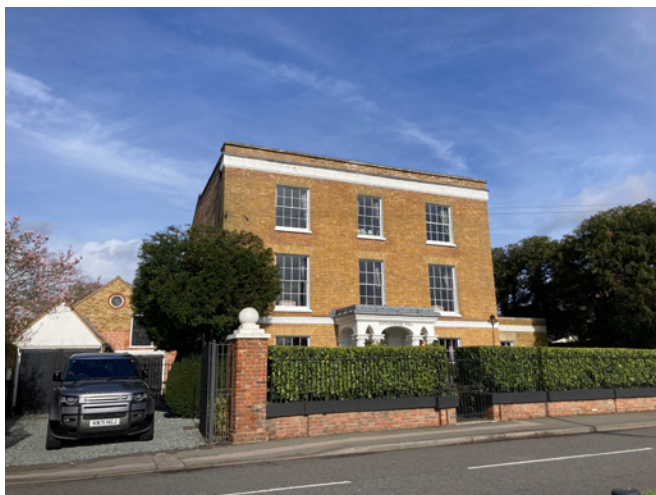
Exposed yellow brick to the principal elevation of Battlecrease Hall, to the east of the Conservation Area.

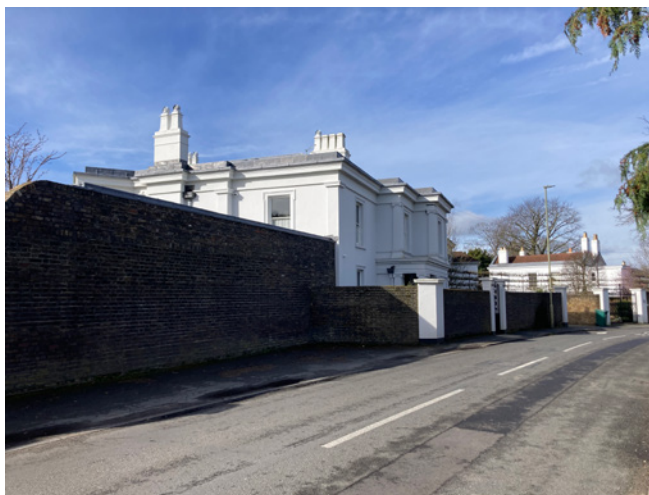
The white stucco finish to Dunally House on Walton Lane is characteristic of the Conservation Area, as is the substantial brick wall which bounds the property to the east.

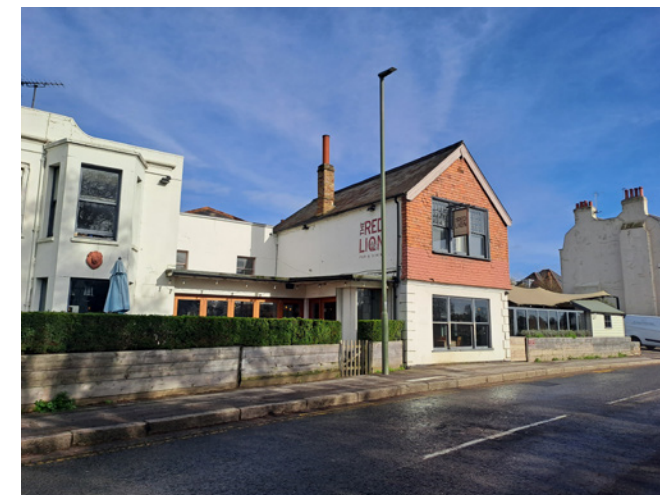
Hung clay tiles to a street-fronting elevation at the Red Lion, Russell Road.

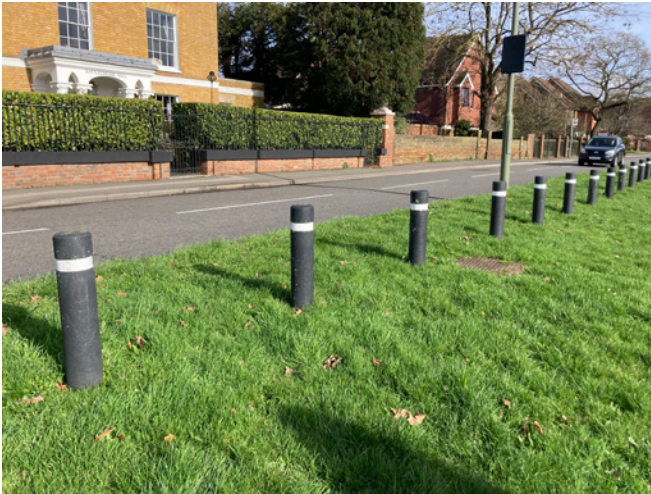
Modern bollards edging the village green detract from the historic character of the Conservation Area.

Public realm features, including bins, bollards, seating and planters, etc. often become outdated in their appearance. This can be due to heavy wear, antisocial behaviour or as a result of poor design and short-lived trends. Successful public realm schemes are contextual, using high-quality materials that echo the character of the wider area. Any additions or amendments to the public realm will also need to take account of highways and other relevant regulations.

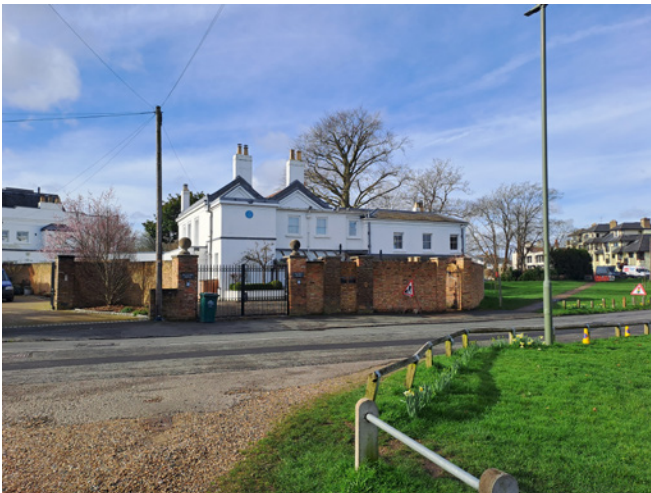
- **Street lights, telecommunication poles and wires:** Prominent poles with radiating wires and tall modern street lights are positioned at intervals throughout the Conservation Area. Visually, these compete with the historic character of the streetscapes. There are opportunities for relocation below ground (in the case of the telecoms) and replacement with more historically appropriate versions (in the case of the street lights) to enhance the Conservation Area.

Examples of the prominent modern telegraph poles and street lights, these are in front of Peacock House and Halliford House on Walton Lane.

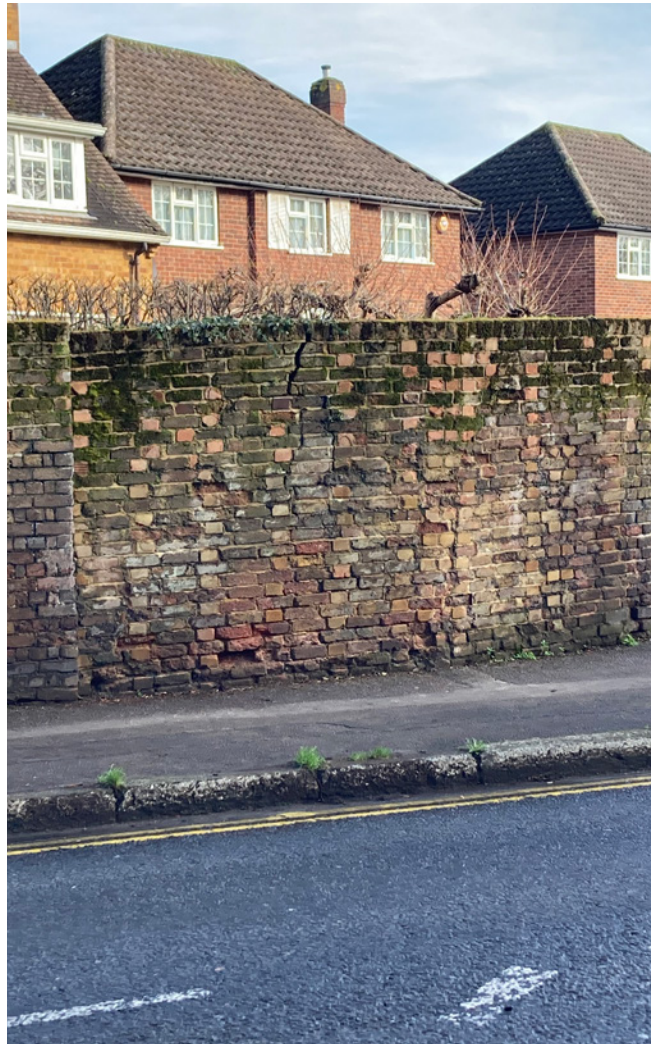
- **Condition of brick walls:** The brick boundary walls along the north side of Russell Road are suffering from decay due to the use of inappropriate cement mortars and frequent wetting from fast-moving vehicular traffic. Repair using appropriate lime-based mortars, reducing water pooling on Russell Road and reducing traffic speeds will assist in improving the visual appearance of the Conservation Area and preventing future issues reoccurring.

Many of the important brick boundary walls along the north side of Russell Road are in a deteriorating condition and in need of appropriate repair.

Beyond general conservation best practices, there are limited opportunities for additional enhancement within the Conservation Area. There is scope for enhancing the public realm of the Conservation Area including pavements and the edging to the village green. There are also individual improvements to dwellings including restoring timber sash windows, reinstating appropriate brick boundary treatments and undertaking repairs to decaying brick boundaries.
